Hekeao/Hinds Managed Aquifer Recharge Trial

Year 3 Annual Report

(June 2018 – May 2019)

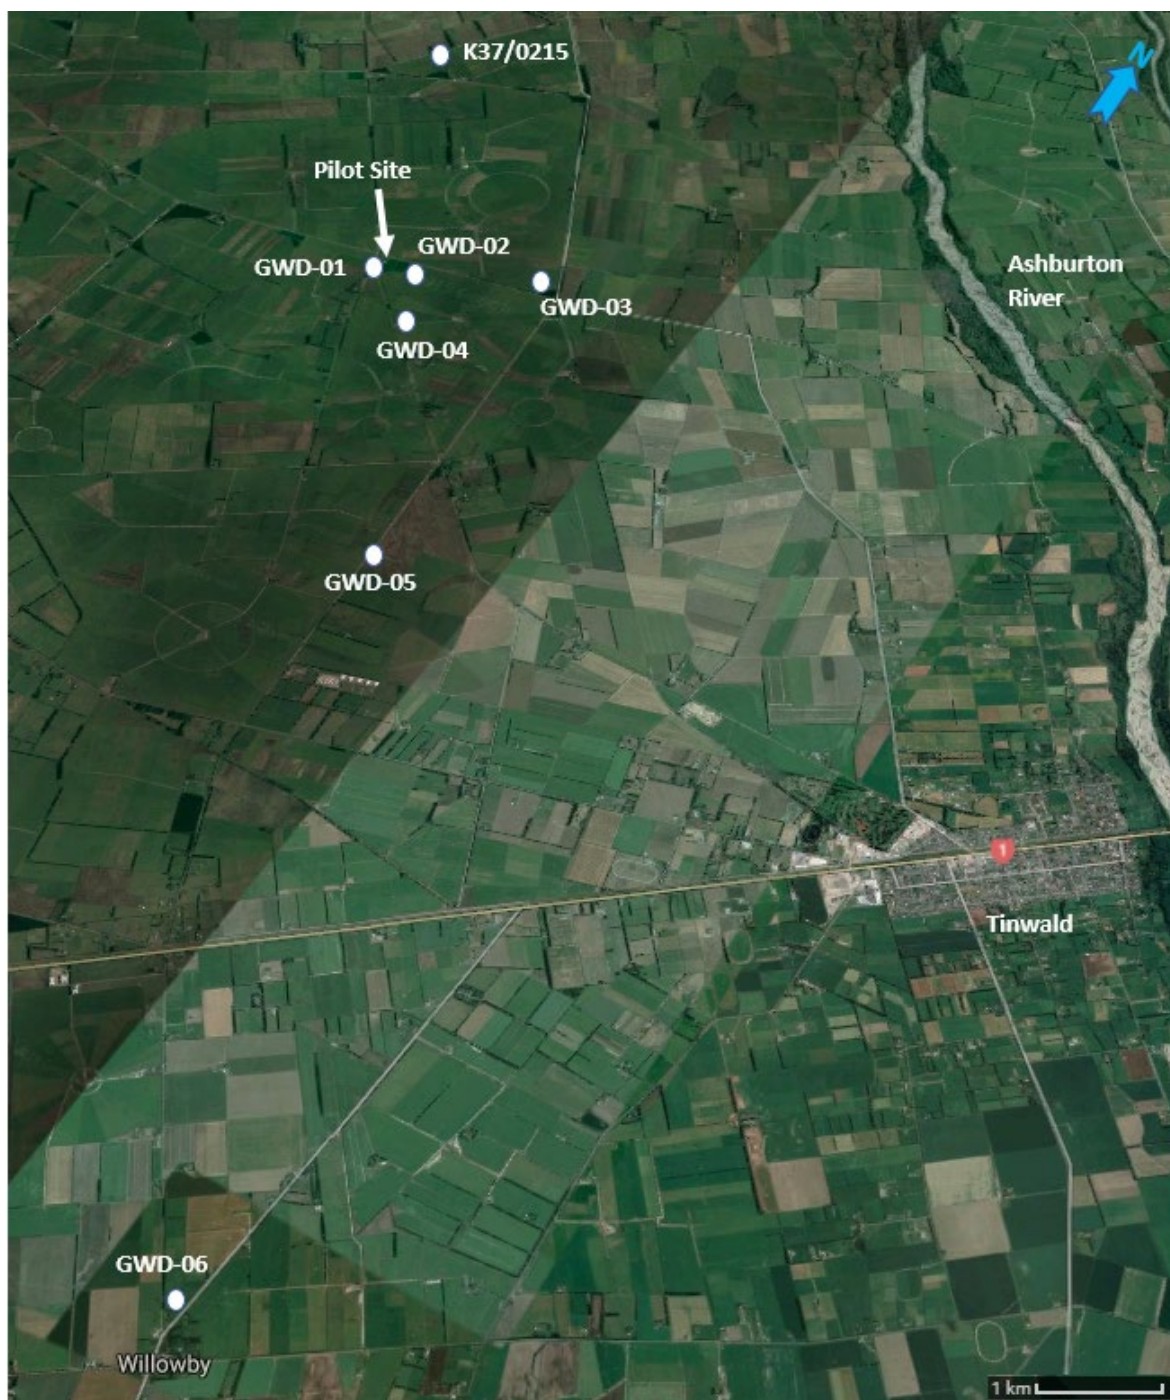
Figure 2-6: Pilot Site groundwater level monitoring

Recharge from the Pilot Site causes a groundwater pressure response which increases connected local groundwater levels relatively quickly, with local geology and hydraulic gradient determining the pressure response shape. Land surface recharge from rainfall, irrigation and race losses also increase groundwater levels, while groundwater pumping decreases groundwater levels. The relative proportions of these effects determine the groundwater level changes over time at different locations. To assist in understanding the influence of Pilot Site recharge on groundwater levels, loggers with a 15 minute recording interval were installed in potentially influenced wells, numbered GWD01 to GWD06 in Figure 2-6.

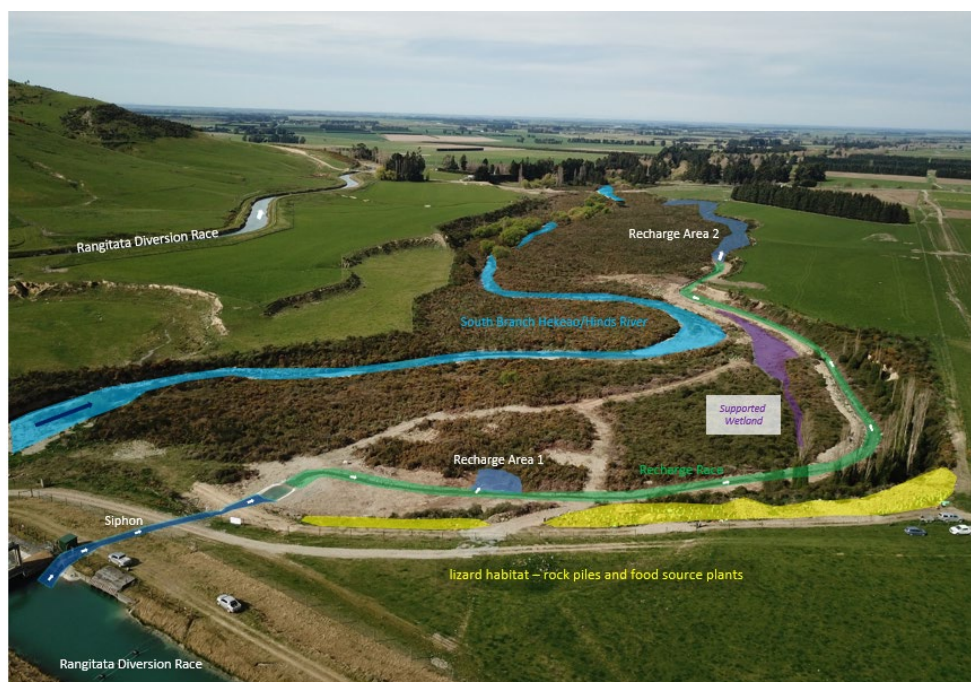
Figure 3-2: HHRP site overview

Figure 3.2 shows a recharge race (in green) supplying two recharge areas (in blue). Groundwater monitoring bores are situated in the clearings. Table 3-1 presents the monitoring requirements for HHRP consent CRC186228.

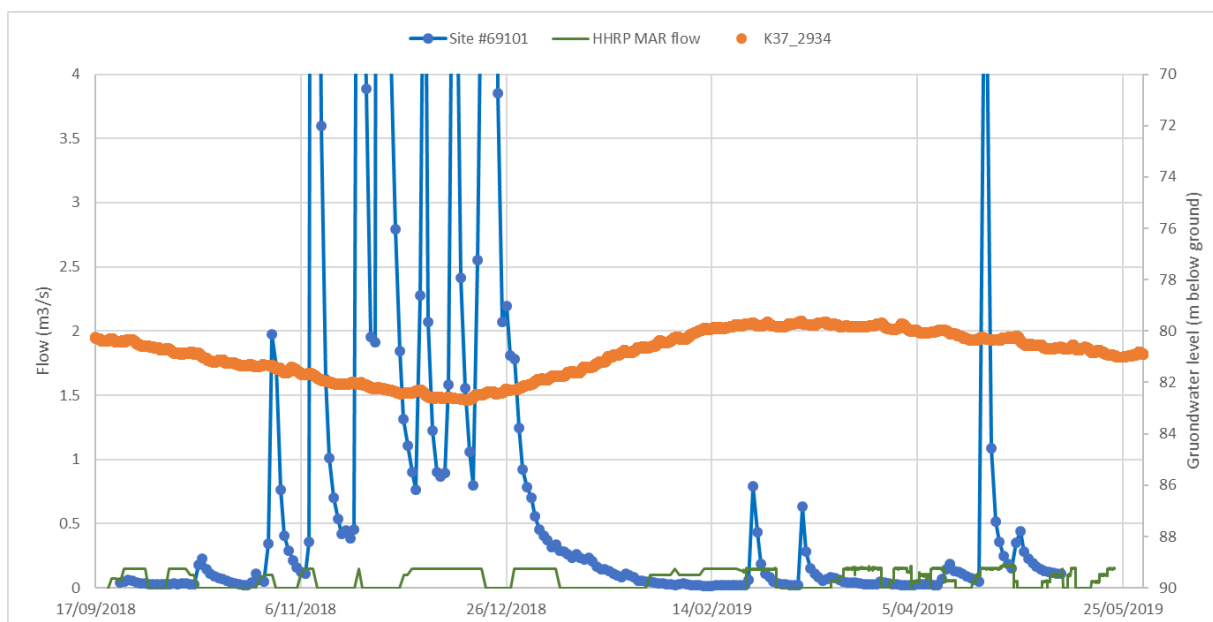
Figure 3-8: HHRP flow, Hinds River flow and K37/2934 groundwater level

Figure 3-8 compares Hinds flow (up to 4 m³/s) at the RDR Siphon, HHRP flow and depth to groundwater in K37/2934. This deep bore beside the river responds more slowly (approximately 50 days) to large freshes. The effect of HHRP flows is immeasurable but may be clearer during a long period of low flows/groundwater.

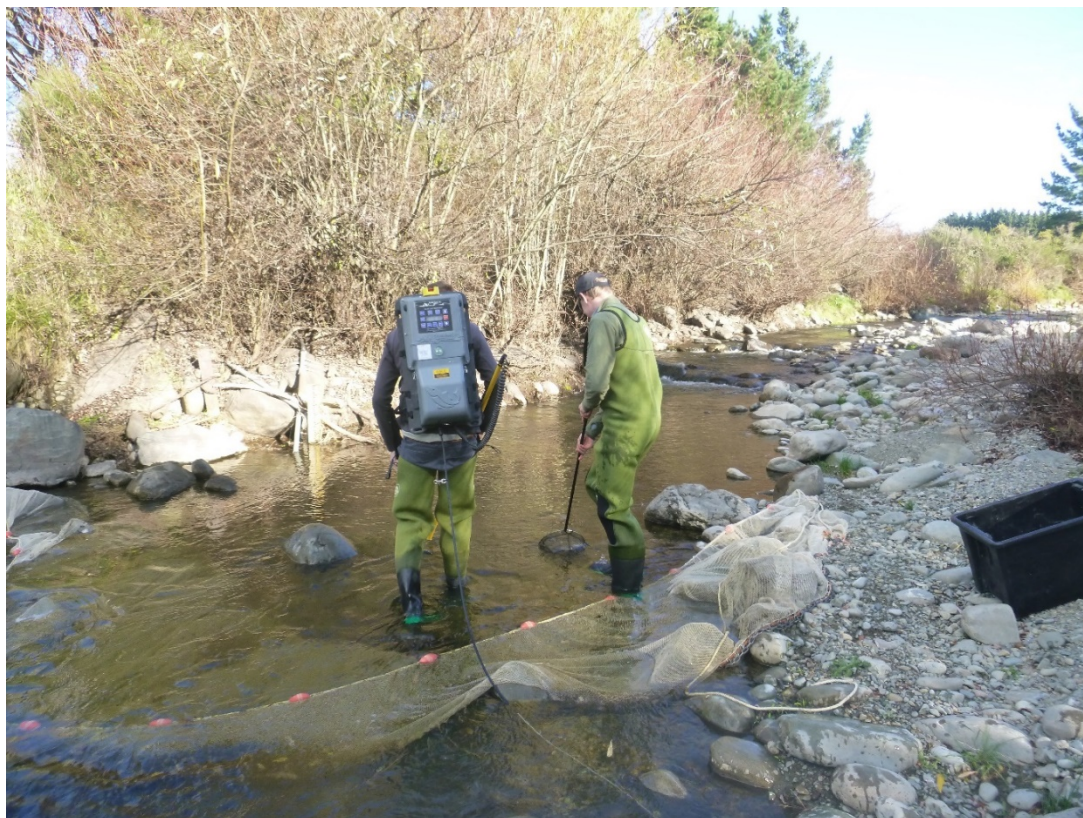
Figure 3-13: Electric fishing at the South Hinds site in April 2019

Annual monitoring of fish diversity and abundance by electric fishing and trout spawning counts remain the preferred methods for assessing long term responses of the fish populations of the Hinds River to the enhanced flow conditions expected to result from MAR. At this time annual surveys since 2017 are contributing to identifying fish diversity and population baselines against which achievement of MAR environmental targets can be measured.

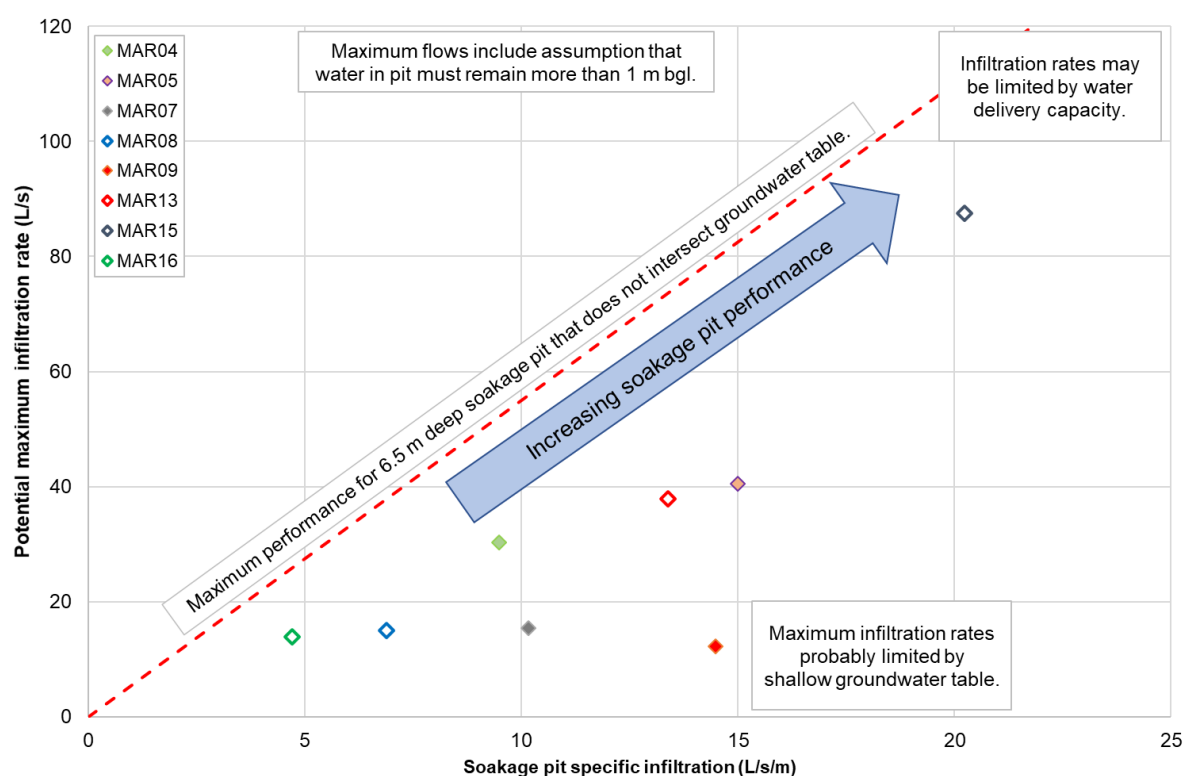
Figure 4-2: MAR test site performance analysis

Hydraulic testing for twelve of the sixteen test sites was conducted between February 2018 and February 2019. Site selection, water delivery infrastructure, and hydraulic testing methods are described in the Year 2 Report. Initial results are presented below in Figure 4-2. Each point combines the tested specific infiltration rate for the site against the potential maximum infiltration rate. The dotted line refers to the relationship between these two variables based on 6.5 metre pit depth minus the 1 metre minimum depth to groundwater requirement. A general conclusion from results to date is that greater infiltration performance can be expected in the upper catchment sites due to a lower chance of shallow groundwater mounding limitations. The location of lower catchment sites is likely to be more critical than upper catchment sites so that their operations can most effectively target priority groundwater quality areas such as community drinking water supplies. Sites 3, 6, 10 and 12 have not been included in Figure 4-2 as their testing did not produce data sets suitable for calculating both performance parameters.

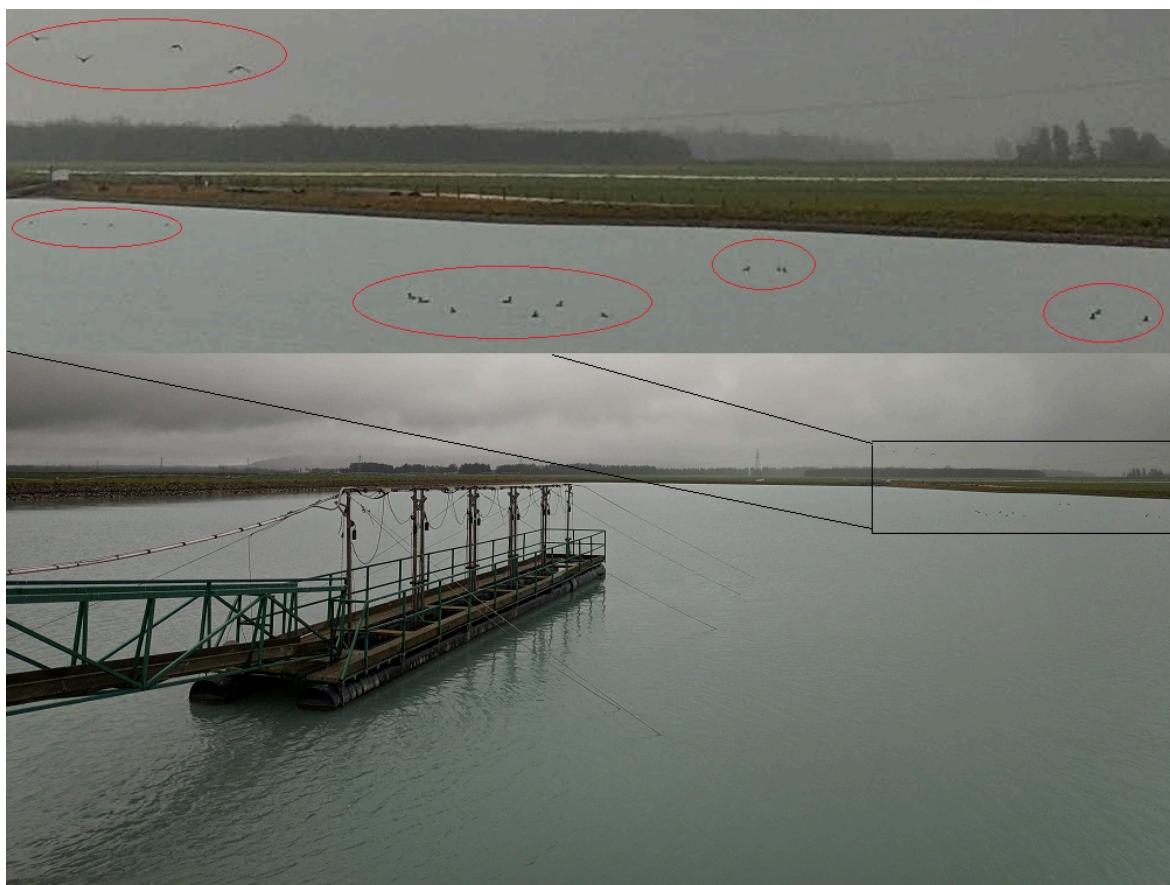
Figure 4-5: Pond #2 photograph showing presence of birdlife. Larger numbers are out of frame, having been disturbed

Results show *E. coli* counts of source water entering the Valetta piping network at 172 MPN/100 ml. Historical, water delivered by the RDR is thought to have *E. coli* counts ~30 MPN/100 ml. At Pond #1, the *E. coli* count increased to between 1414 and 1986 MPN/100 ml. At Pond #2 the *E. coli* count remained elevated, ranging from 1300 and 1986 MPN/100 ml (see Figure 4-4 below). During the investigation, substantial birdlife was observed at both Pond #1 and Pond #2. Images were taken at both ponds, though many birds have been scattered upon arrival and are missing from the images (see Figure 4-5 below).

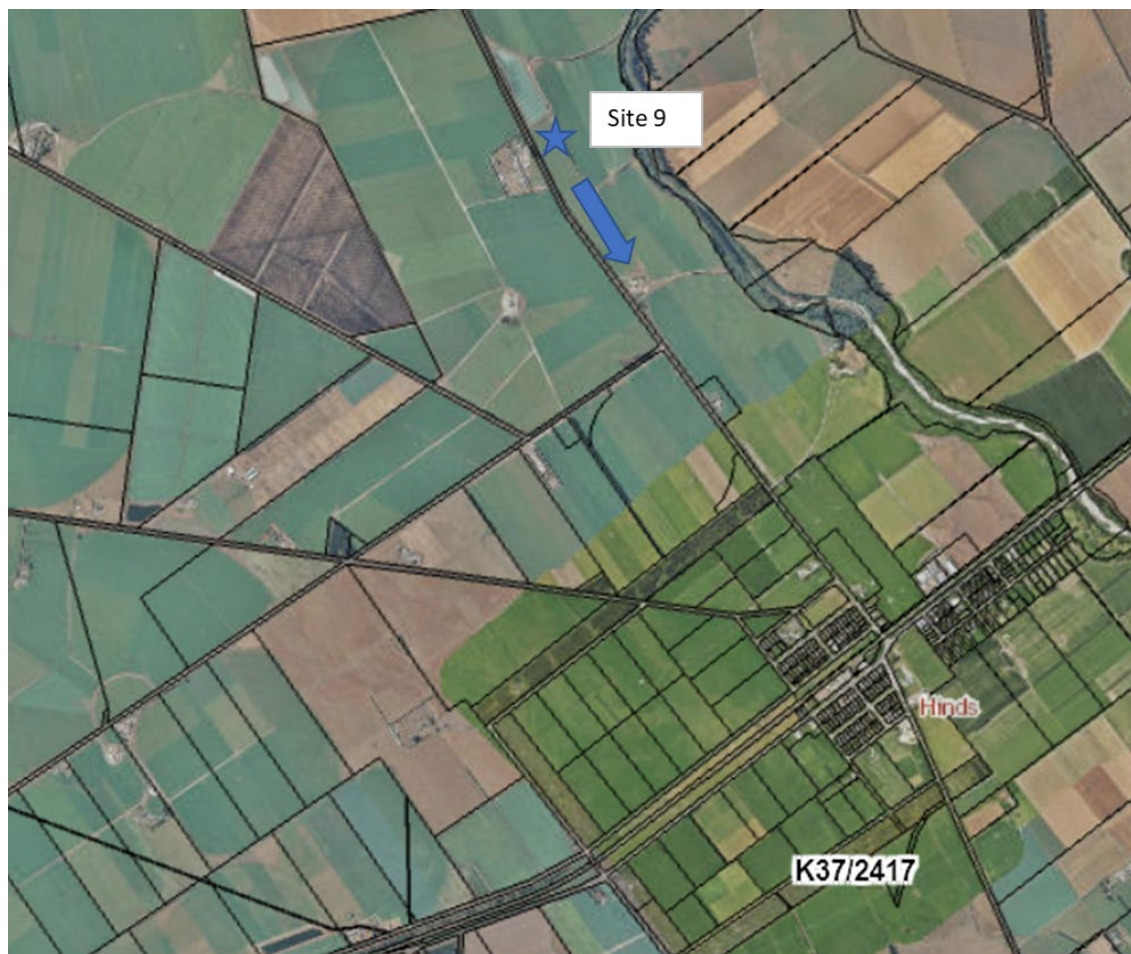
Figure 4-9: Site 9 Year 3 monitoring

Site #9 is up-gradient from one groundwater level bore (K37/2417) sampled most months. Figure 4-9 above compares Site #9 recharge flow, Hinds Plains rainfall and groundwater levels in K37/2417. Groundwater levels clearly respond to large rainfall events and seasonal cumulative groundwater pumping. To understand whether there is also a measurable contribution from Site #9, a reasonable period of recharge without significant rainfall or pumping effects would be necessary. Recent moderate depth groundwater nitrate-N concentration near this site is understood to be approximately 11 mg/l, but further detail is not currently publicly available.

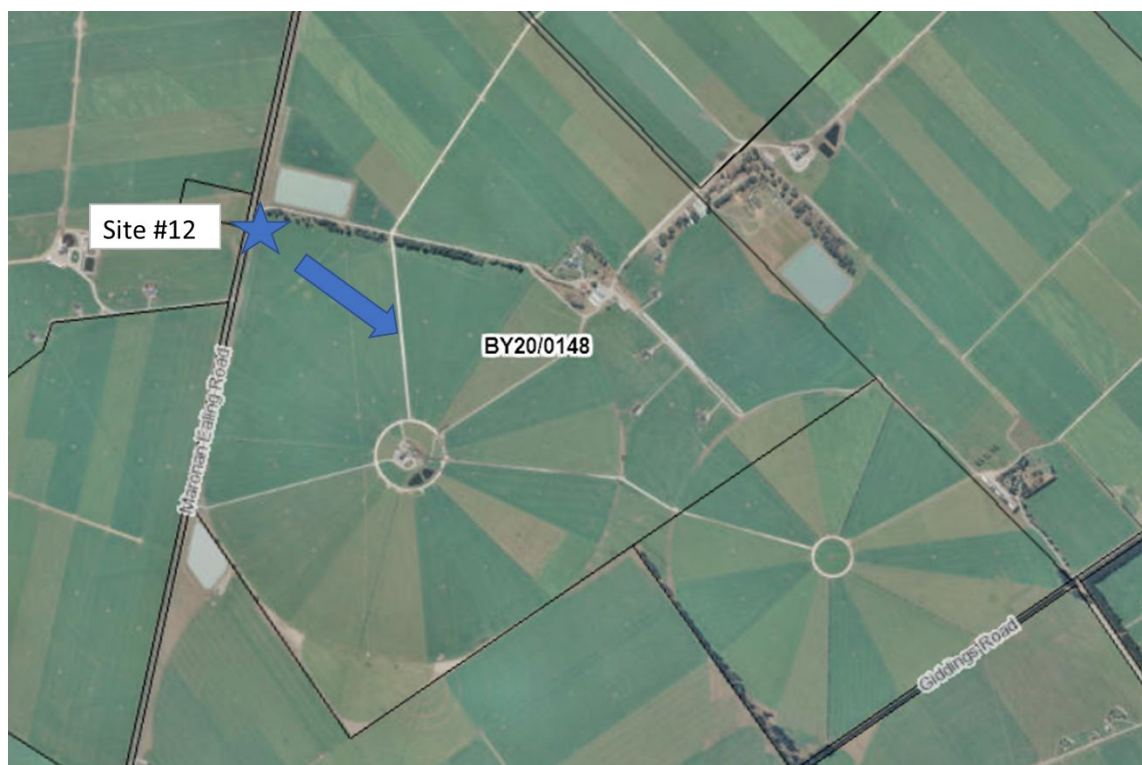
Figure 4-11: Site 12 Year 3 monitoring

Despite recharging less than 100,000 m³ in Year 3, Site #12 is included for analysis (see Figures 4-10 and 4-11) as it has a nearby down-gradient bore (BY20/0148) with the second nitrate logger installed as well as regular groundwater level measurements. As with the other assessed test sites, groundwater levels respond positively to the November 2018 rainfall. Nitrate concentrations also drop at this time. The beginning of the late January – April 2019 operational period for Site #12 is followed closely by a slowing in groundwater level decline without a contribution from rainfall. After approximately 5 weeks, the nitrate-N concentration drops from approximately 15 to 13 mg/l. Approximately 2 weeks after operations cease, the nitrate-N concentration jumps back up to 16 mg/l. These results could be an indication that Site #12 recharge is influencing BY20/0148 level and quality, however additional land use information and monitoring during this period is required to substantiate this conclusion.

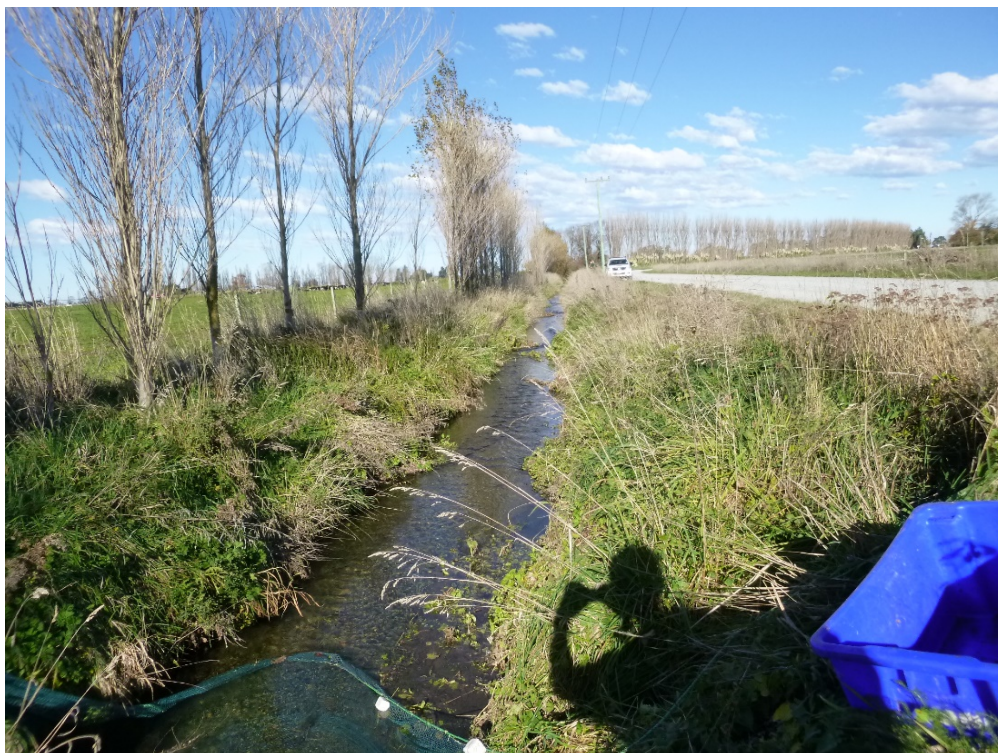
Figure 5-1: Monitoring site 1 on Windermere Drain prior to boulder weir placement, May 2015

The habitat created by the weirs was a simple attempt to simulate the complex interactions of flow, depth, velocity, gradient and substrate that occur naturally in streams and provide a wide range of niches for a wide range of stream life. The make or break point of the enhancement was not going to be the immediate reaction of fish to creation of habitat directly attributable to introduction of the weirs but rather what long-term changes were naturally created in the drains from the interaction of flow and boulder substrate. The first evidence of this interaction did not occur until two years after weir creation with the flood flows of July 2017, estimated to be a 1 in 40-year event. In reality this flood reset the natural environment inclusive of the boulders and monitoring the true impact of the boulder induced habitat on fish populations effectively began after July 2017 (see Figures 5-1 and 5-2).

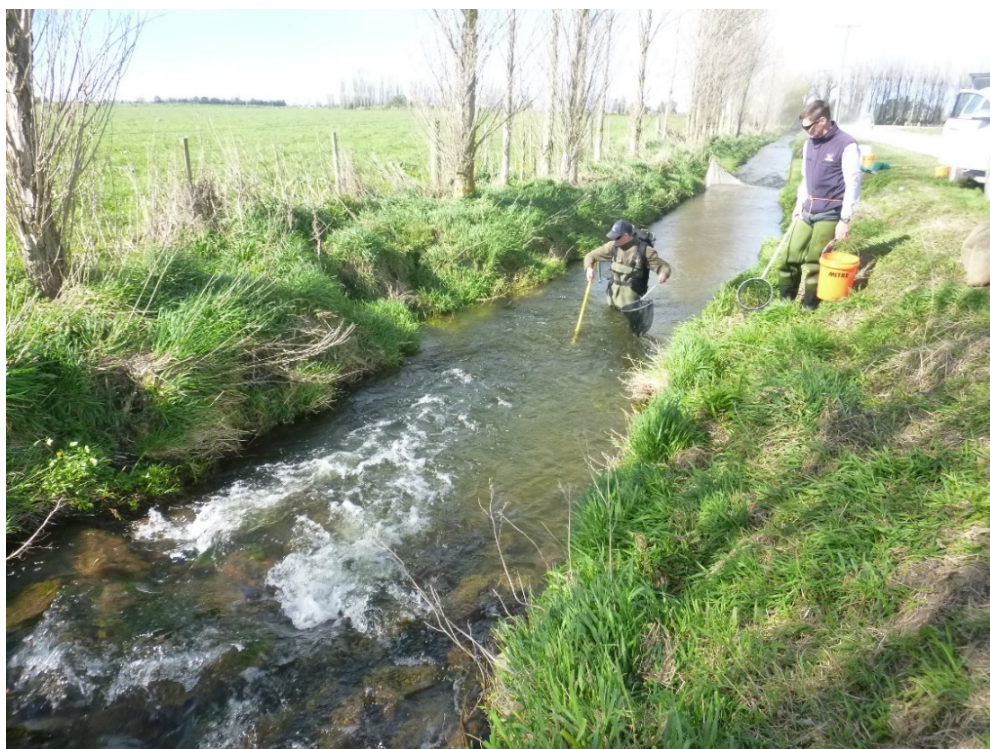
Figure 5-2: New pool below the weir in Site 1 of Windermere Drain, September 2017

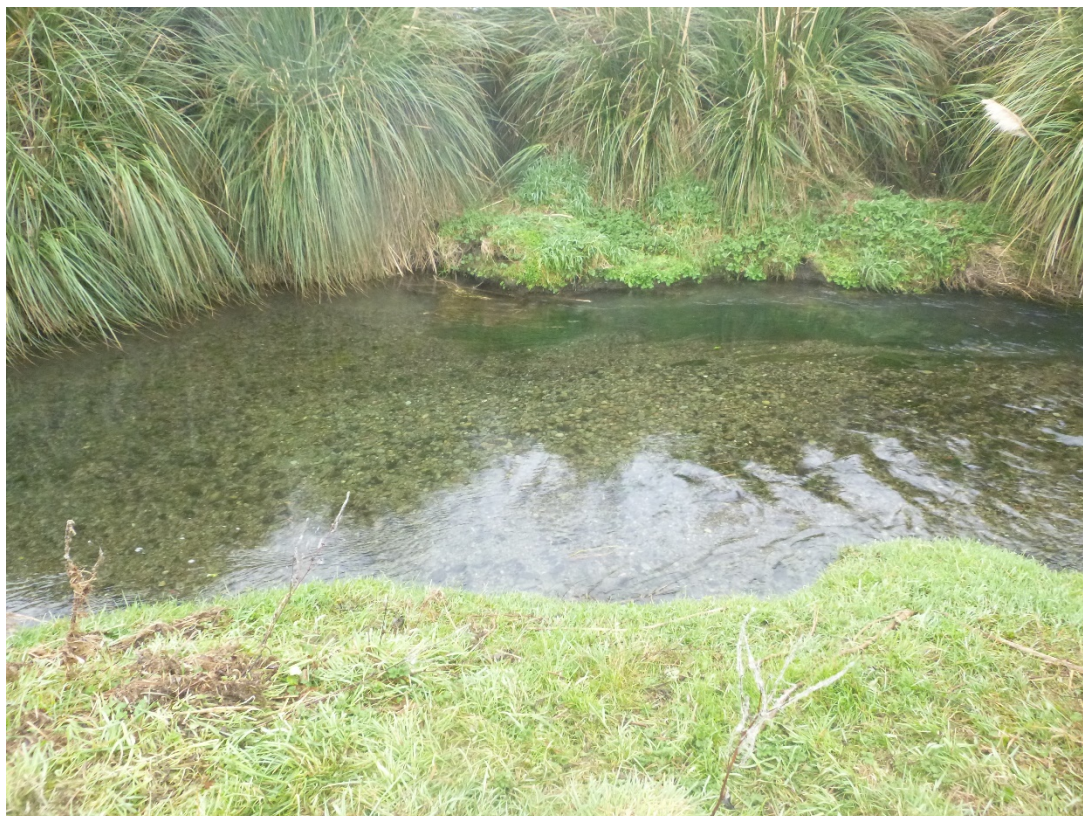
Figure 5-3: Trout redd (clear gravel patch mid-stream) in Boundary Drain downstream of Trig Pole Road, 10 July 2019

A survey to identify brown trout spawning was completed on 10 July 2019. Four trout redds (nests) were identified compared to two in 2018 and none in 2016. These numbers are encouraging and provide the necessary foundation for a good trout population. I believe the spawning numbers, which are indicative of adult trout presence, show the benefit of sustained flows in Boundary Drain. If adult trout are lost during prolonged low flows it takes at least three years before any surviving juveniles grow to maturity and spawn.
