Hekeao/Hinds Managed Aquifer  
Recharge Trial  
Year 4 Annual Report  
(June 2019 – May 2020)

Dr Brett Painter (Environment Canterbury)  
Justin Legg (MHV Water)

*Hekeao/Hinds Managed Aquifer Recharge Trial - Year 4 Annual Report*

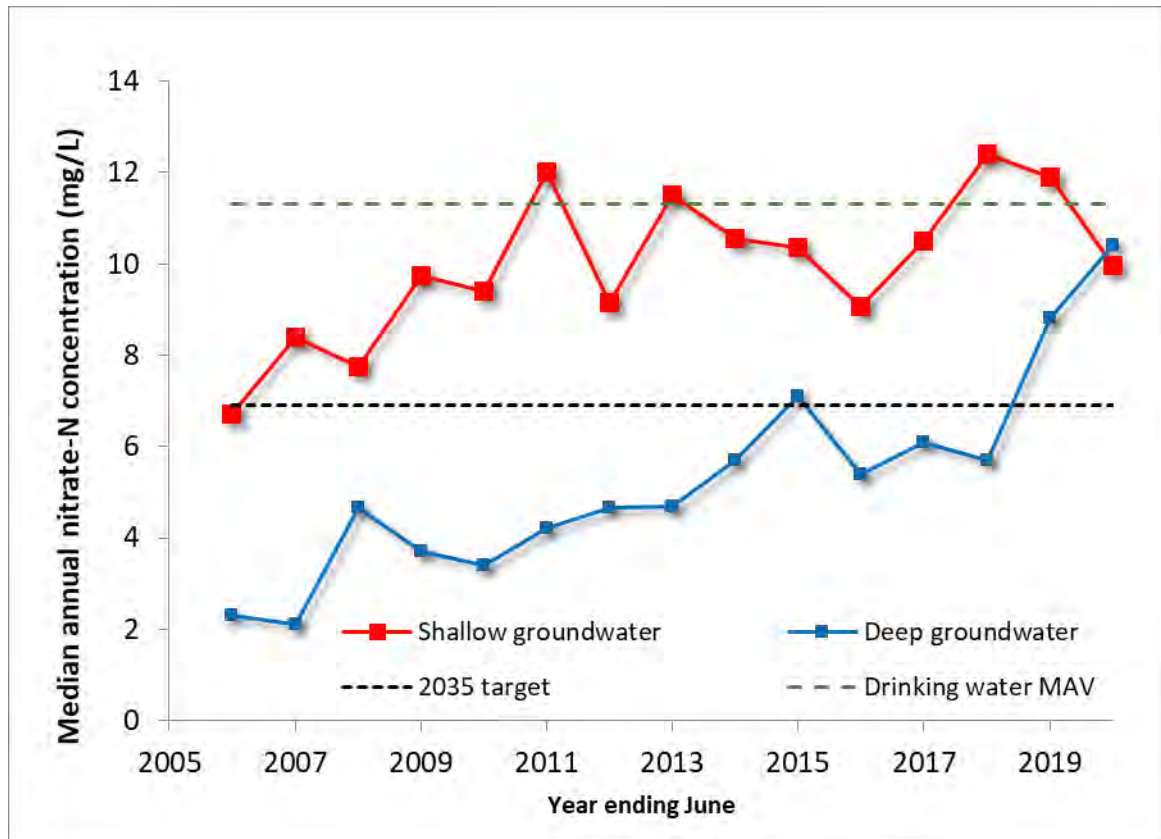
Figure 1-1: Plan Change 2 to Canterbury’s Land and Water Regional Plan – Hekeao / Hinds Plains median annual nitrate-nitrogen concentrations

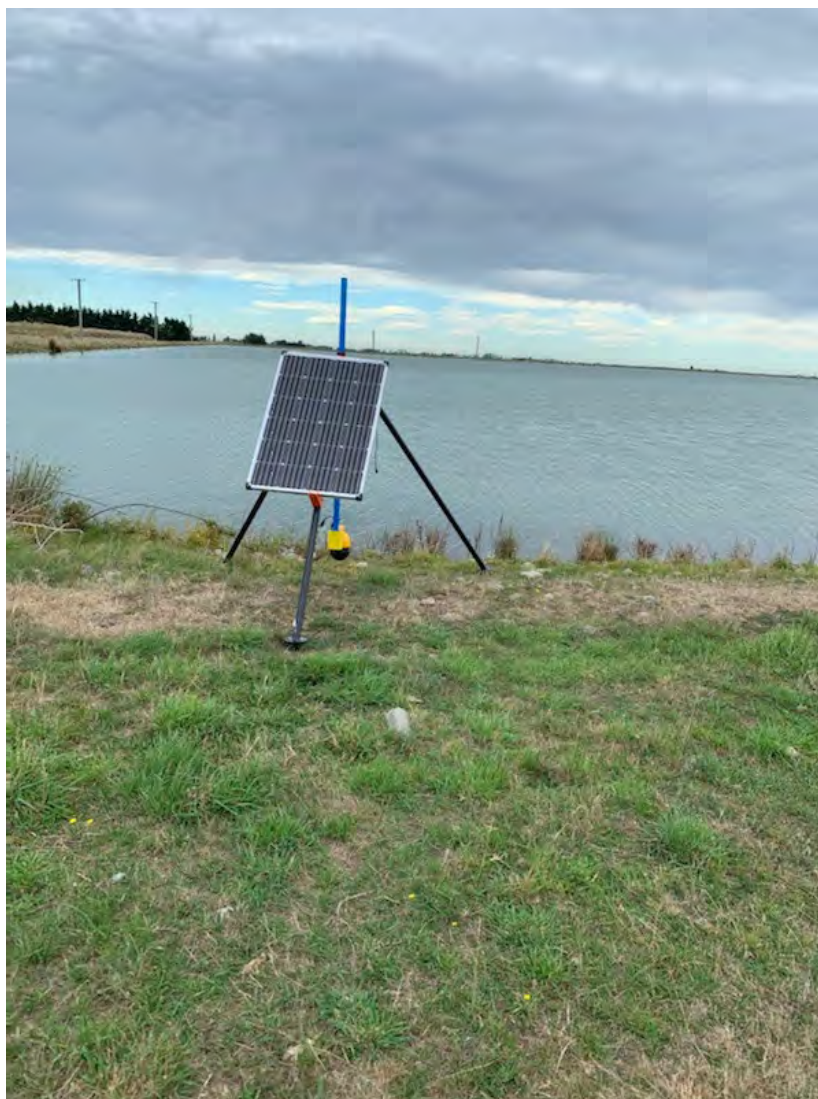
**Figure 1-4: Hekeao Hinds MAR laser bird scarer**

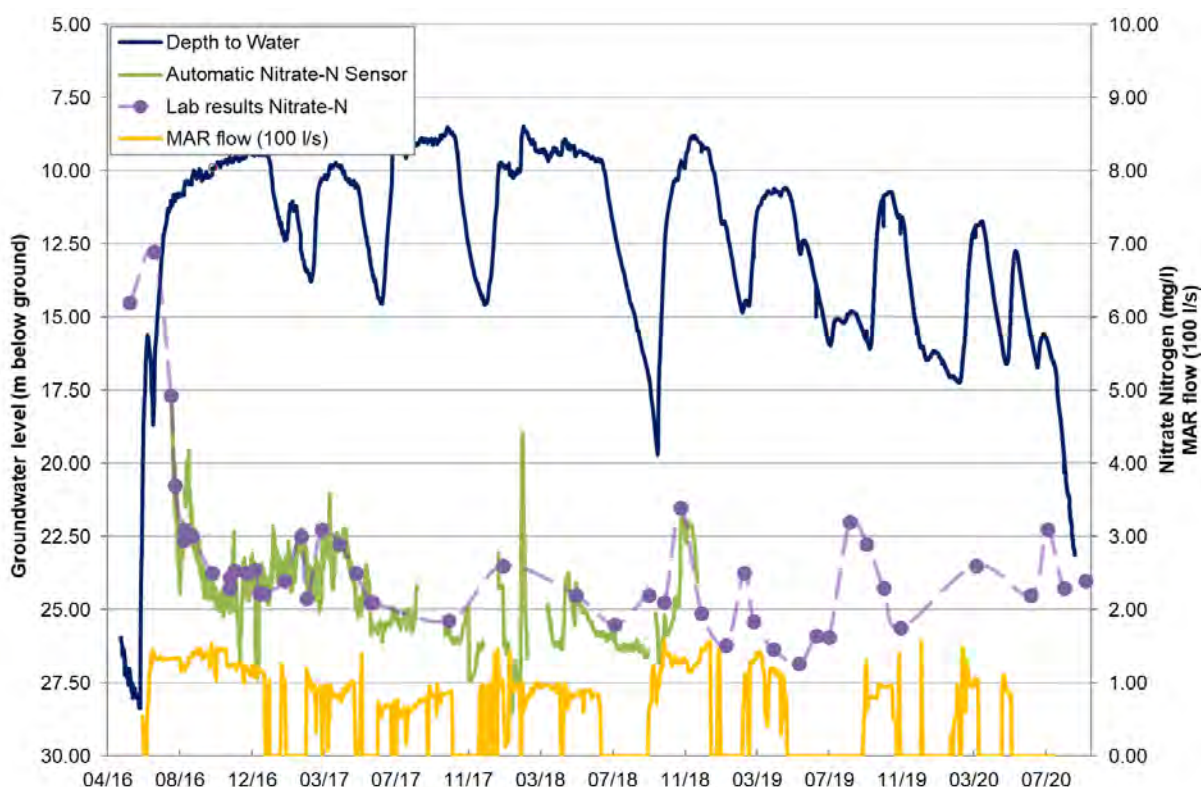
Figure 2-2: Lagmhor Pilot Site (MAR 01) operational and key down-gradient monitoring

Figure 2-2 presents recharge flows and local monitoring for Years 1-4. Recharge flows (in hundreds of litres per second) are shown in yellow, with maximum recharge of approximately 140 l/s, and significant periods in recent years of no recharge (due to supply constraints or prioritisation of available flow to other sites). Measured nitrate-N concentrations are shown in purple, with an in-situ continuous nitrate-N sensor (in green) providing detailed monitoring until late 2019. This record shows nitrate-N at 6-7 mg/l immediately pre-MAR, reducing to 1.3-3.5 mg/l with MAR. Concentrations exceed 3 mg/l after a period of no MAR, but quickly drop back to below 3 mg/l once MAR resumes. Groundwater levels are presented in dark blue, with reasonably quick level changes when MAR begins or stops. The three significant Year 4 shutdown periods (Valetta maintenance, Rangitata floods and COVID-19 shutdown) significantly limited operations, with resulting decreases in groundwater levels and increases in nitrate-N concentration starting to show. Discharge was not required to cease as required by consent conditions on Hinds Plains Rainfall & Parakanoi Drain flow exceedance or *E. coli* exceedance during Year 4.

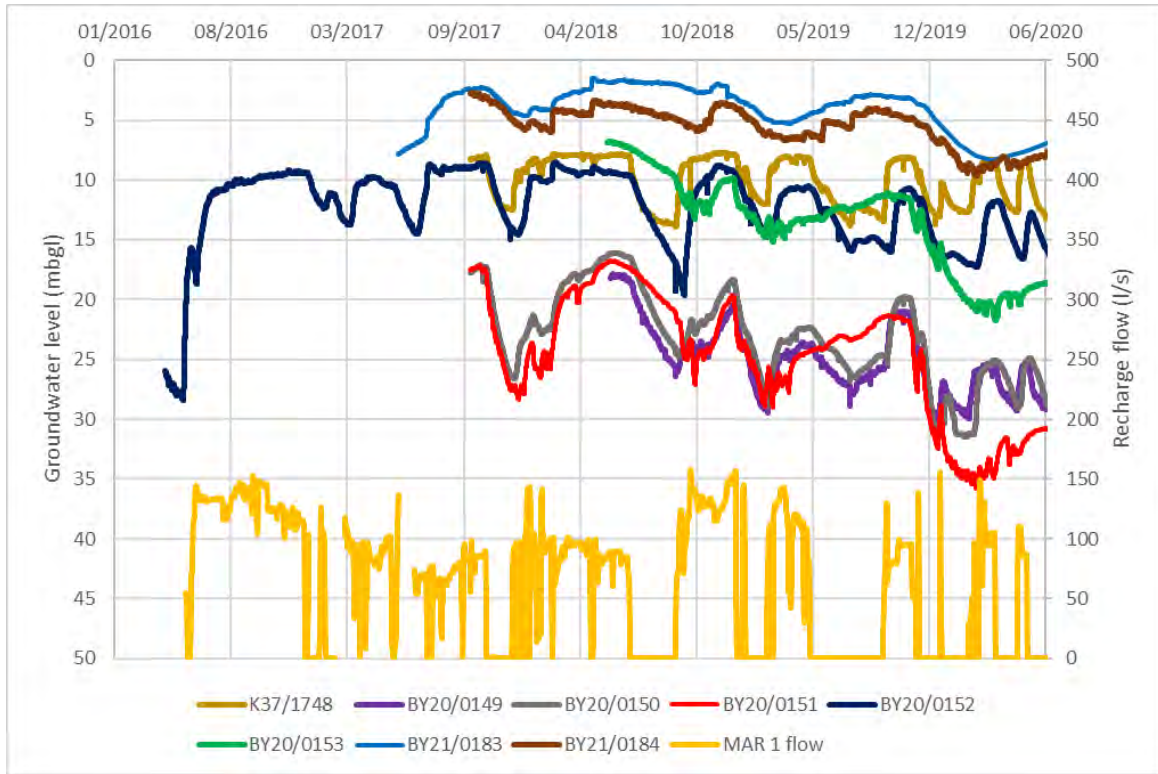
Figure 2-4: Monitoring bore records, colour coded to locations in Figure 2-3

As suggested by the modelling, the bore 6, 7 and 8 hydrographs show groundwater level changes that are difficult to distinguish from their primary correlation with rainfall and pumping periods. This means that spring fed drains below SH1 are unlikely to be measurably increased as a result of Pilot Site operations, though this may change with other nearby MAR sites also operational. The waterways more likely to receive increased flows from higher groundwater levels are those to the north east of the Lagmhor Pilot Site.

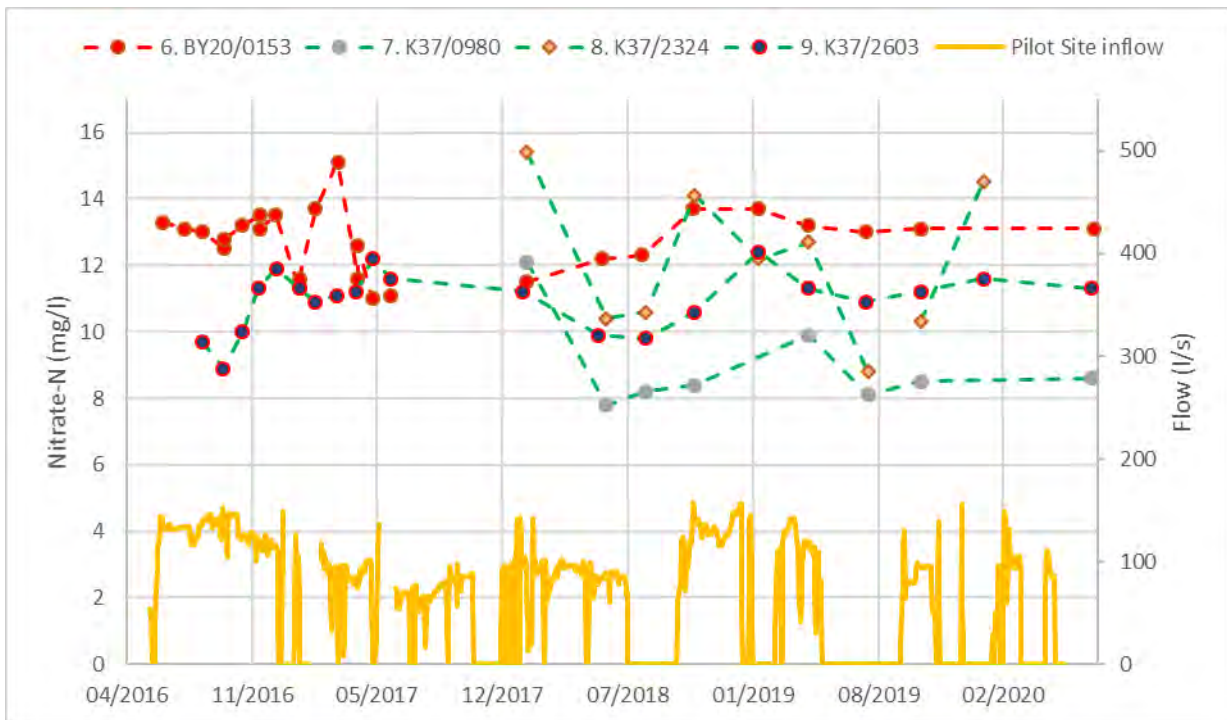
Figure 2-9: Nitrate-N measured concentrations for wells 3-5 km from the Lagmhor Pilot Site

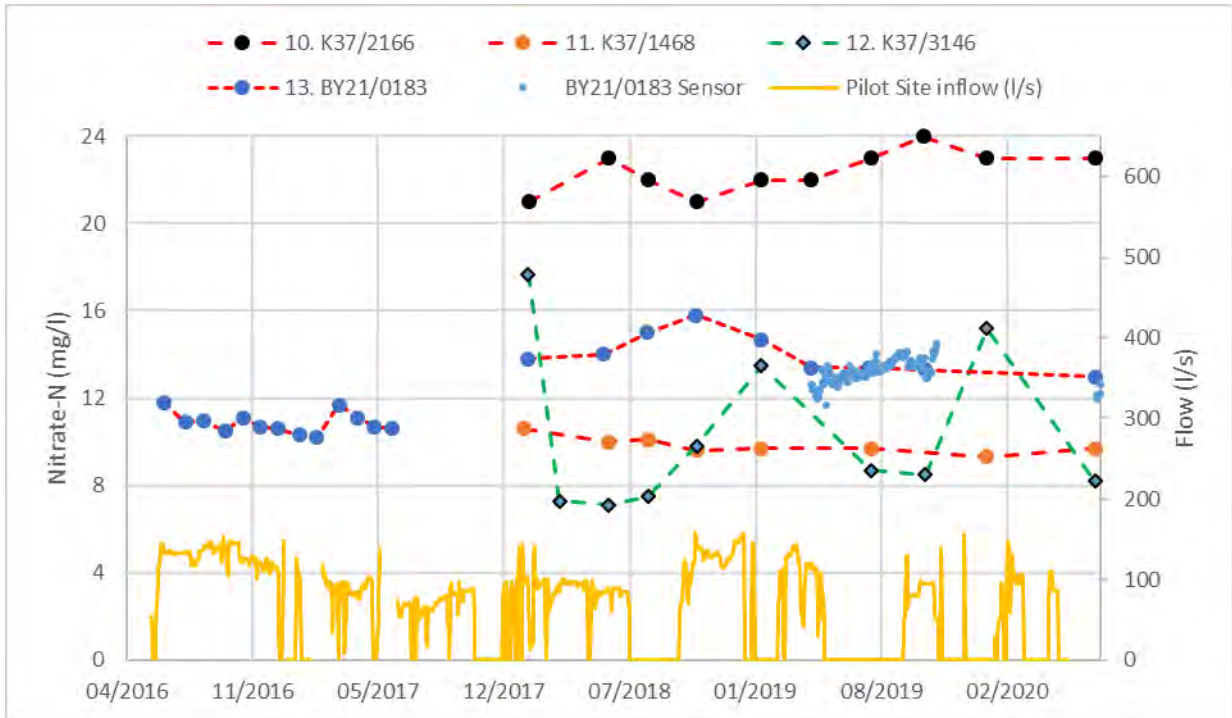
Figure 2-10: Nitrate-N measured concentrations for wells 6-12 km from the Lagmhor Pilot Site

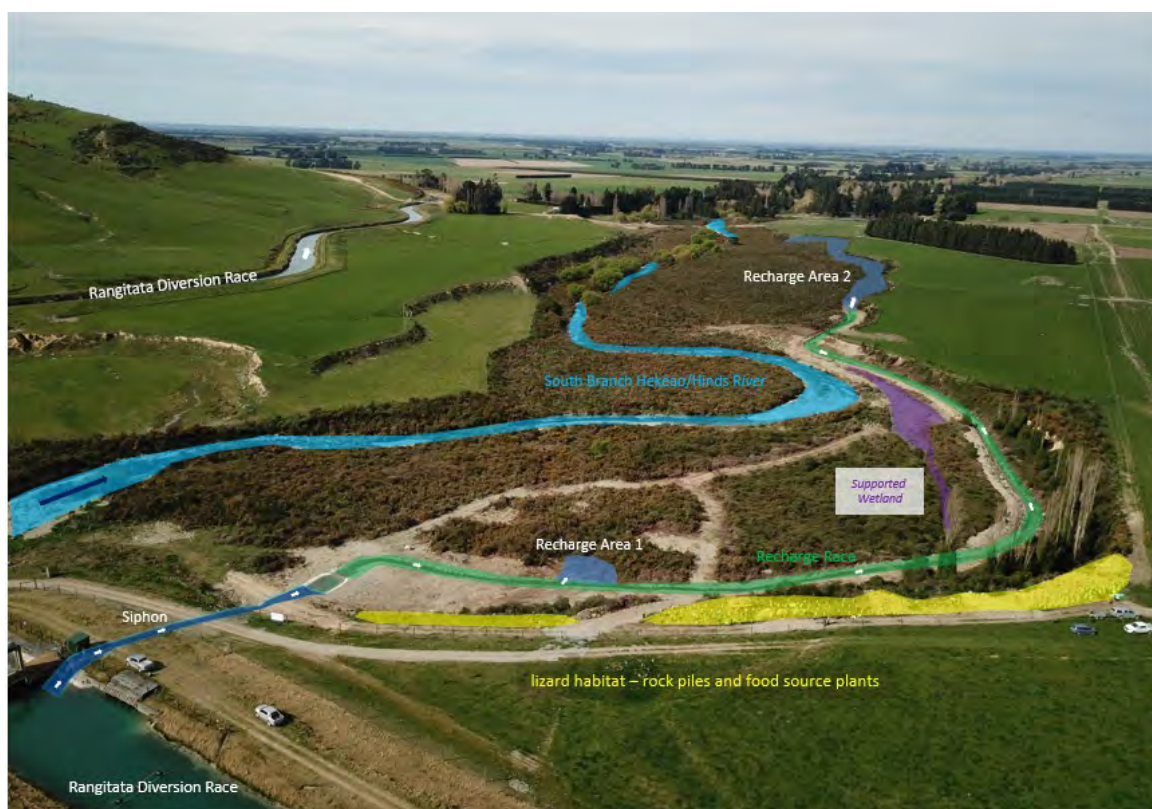
Figure 3-1: HHRP site overview

The Hekeao Hinds River Project (HHRP) has been operational since September 2018 (Figure 3-1). This site receives Rangitata River water, via siphon, directly from the Rangitata Diversion Race (RDR). Consented supply flow is 210 l/s, but a maximum flow rate of only 170 l/s has been introduced to date. In addition to the recharge channels and basins, lizard habitat (under DOC Covenant) has been created away from the flood plain, an oxbow wetland (containing potential Canterbury mudfish habitat) has been rehabilitated and is supported by the raised local groundwater, and native plants (wetland and dryland) have been reintroduced (Figures 3-2 and 3-3).

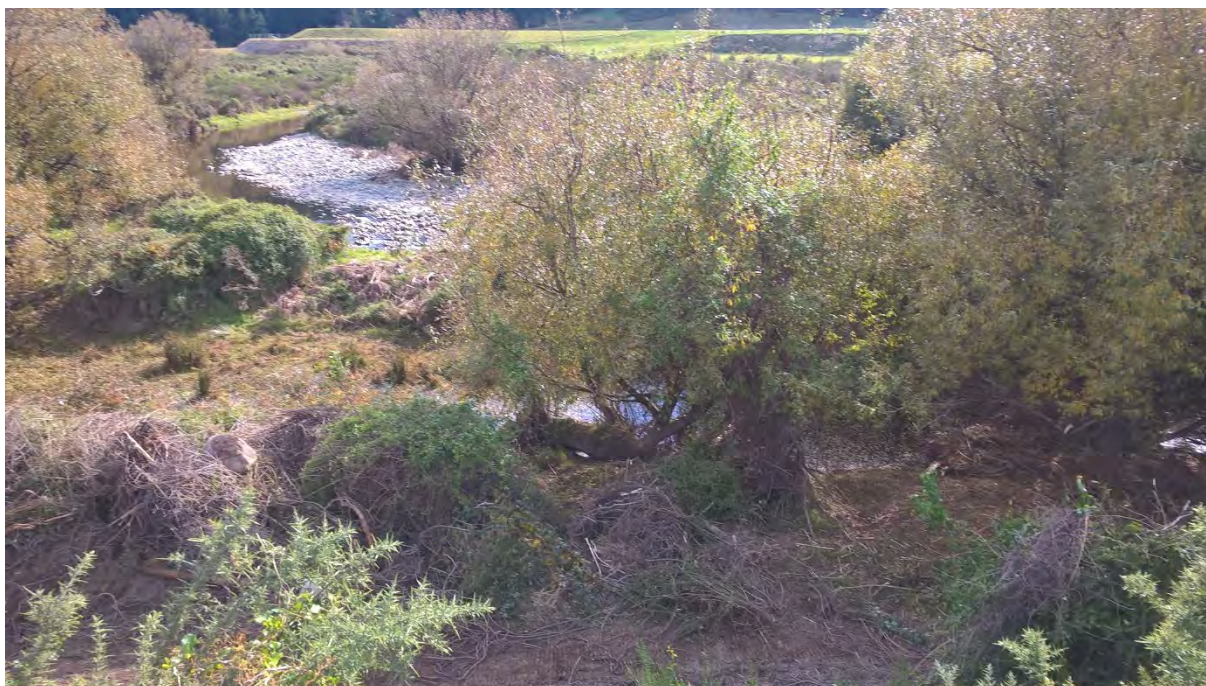
**Figure 3-2: View across wetland to Hekeao / South Hinds River prior to rehabilitation (2018)**

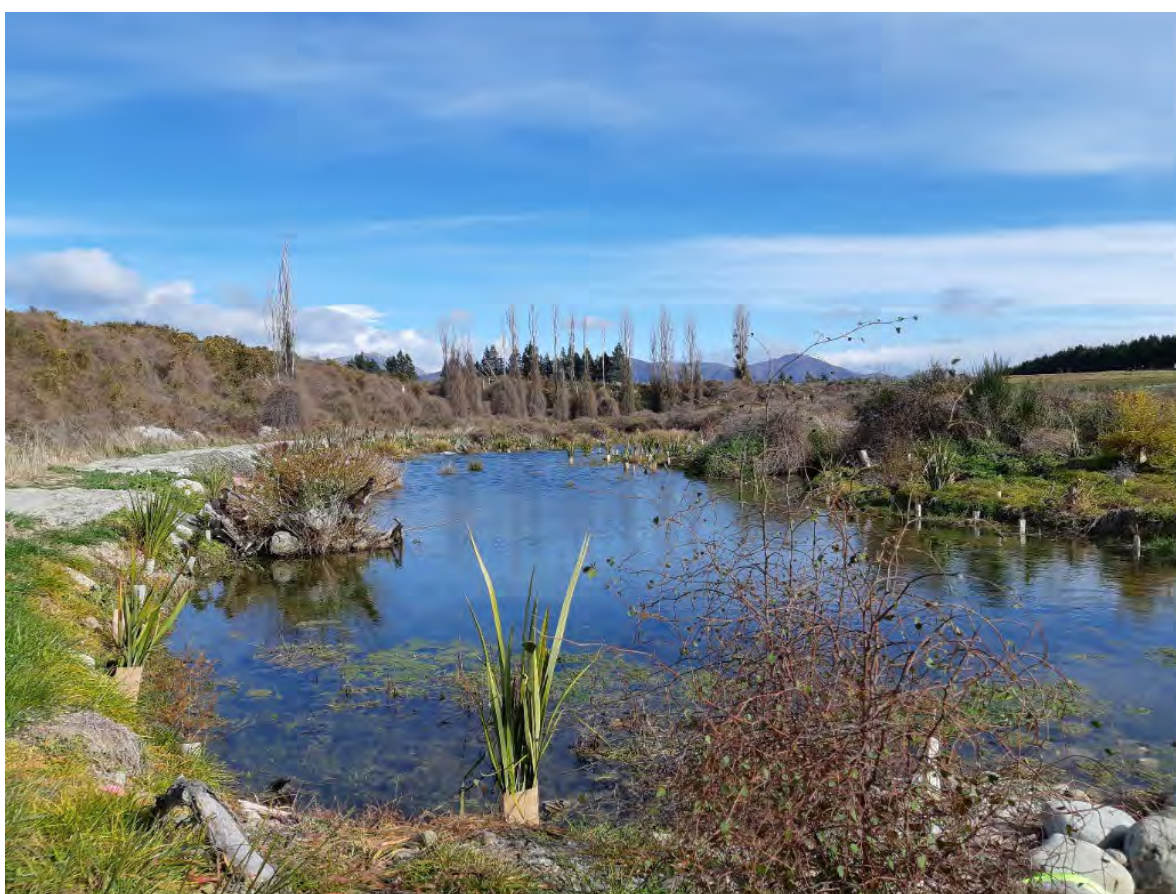
**Figure 3-3: Wetland after rehabilitation (2020), supported by the HHRP and under preparation as Kōwaro / Canterbury mudfish habitat**

In Year 4, additional analysis was undertaken at the HHRP wetland (Fig. 3-3), which was enhanced by the removal of willow trees during site construction. The work included habitat mapping (Fig. 3-20), invertebrate, and water quality sampling. This analysis concluded that the site is expected to be suitable for Kōwaro / Canterbury mudfish release, after the addition of aquatic plants and habitat (tree stumps).

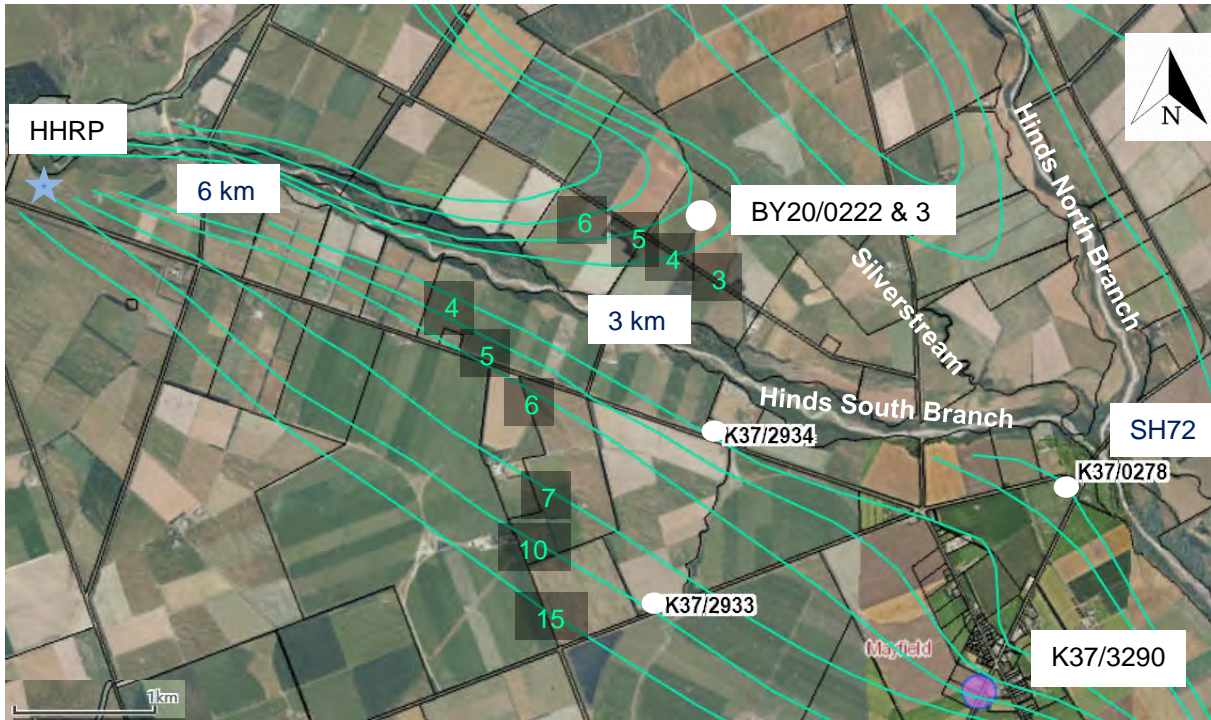
Figure 3-6: HHRP down-gradient monitoring wells and minimum depth to groundwater contours (in m)

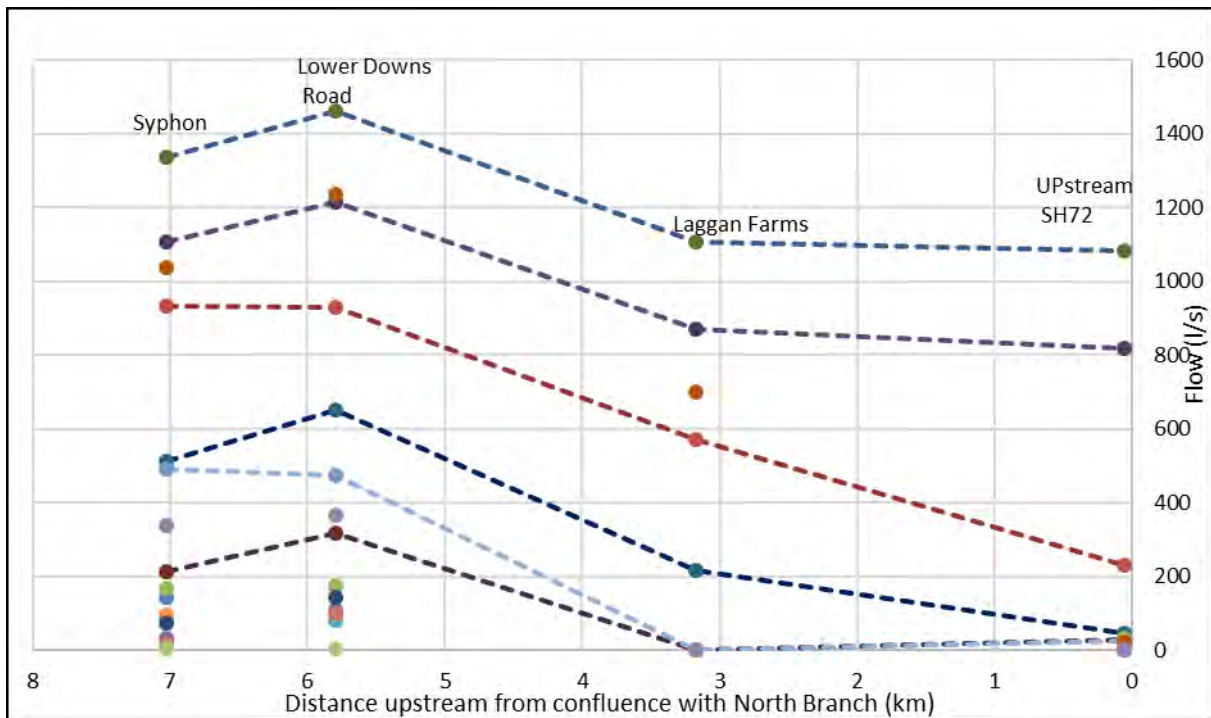
Figure 3-7: Hekeao South Branch Hinds flows from Siphon to the confluence with the North Branch, with key points on Fig. 3-6 (Source: Gabites, 2020)

Figure 3-7 presents the results of a Hekeao South Branch Hinds River gauging survey undertaken by Environment Canterbury Hydrologists during Year 4. It shows that for river flows of up to 500 l/s at the Lower Downs Road (Ballantynes) Bridge, 6 km upstream from the confluence with the North Branch, all flow is recharged to groundwater by approximately 3 km upstream from the confluence. For higher flows, groundwater recharge in this reach is approximately 350-450 l/s.

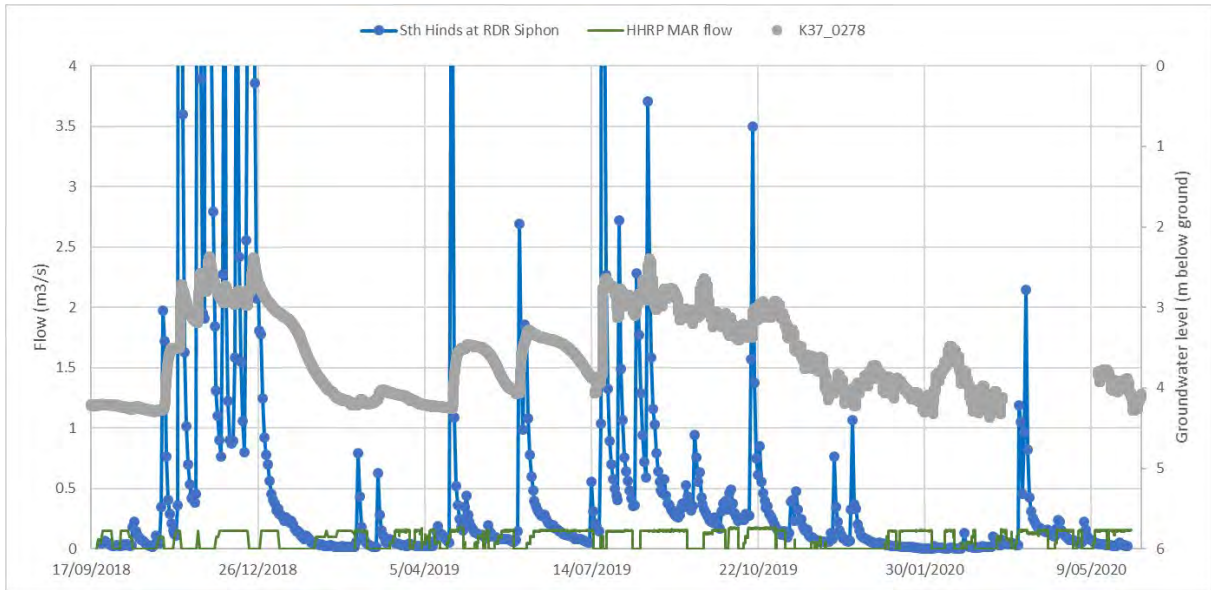
Figure 3-10: HHRP flow, Hinds River flow and K37/0278 groundwater level

Figure 3-10 compares Hekeao Hinds River flow (up to 4 m<sup>3</sup>/s) at the RDR Siphon, HHRP flow and depth to groundwater in K37/0278. This shallow (15 m) bore beside the river, responds quickly (within days) to freshes greater than 1000 l/s. The effect of HHRP flows is therefore expected to be most measurable during sustained periods of naturally low river flow, as in early 2020. Here we can see groundwater levels remaining relatively stable when we would otherwise expect them to decline. Visual observations of surface water flow in the Hekeao / Hinds River during Spring 2020, at the Maronan and Winslow Road ridges, was considered unusual following the low natural river flows since late 2019. Further monitoring will be required before the influence of recharge flow on the extent of flowing surface water in the Hekeao / Hinds River, during dry periods, can be assessed.

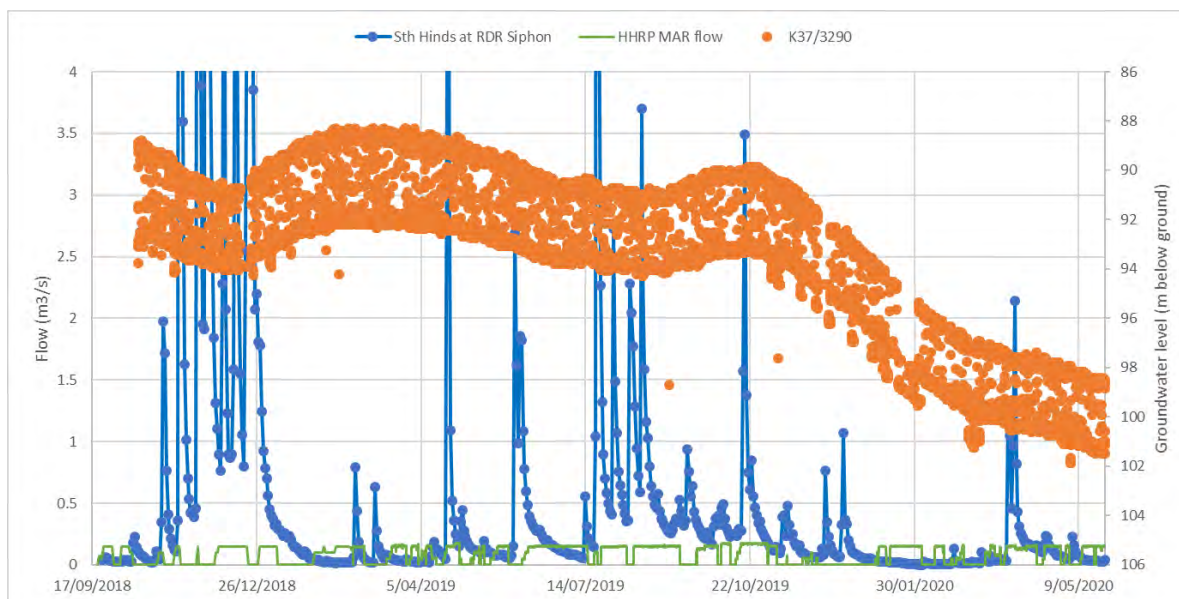
Figure 3-12: HHRP flow, Hekeao Hinds River flow and K37/3290 groundwater level

Figure 3-12 compares Hekeao Hinds River flow (up to 4 m<sup>3</sup>/s) at the RDR Siphon, HHRP flow and depth to groundwater in the Mayfield community supply bore (K37/3290). This deep (119 m) bore, further away from the river (see Figure 3-6) shows significant daily variation in response to pumping. It also shows a slow (approximately 50 days) damped response to large river freshes. Given the dominating factors of bore pumping and large river freshes, the effects of HHRP flow are not likely to be measurable. It will continue to be monitored, however, and assessed in more detail, particularly in case a long period of low flows / groundwater eventuates (e.g., conditions similar to the 2015/16 drought that resulted in this bore dropping approximately 25 m to more than 119 m below ground level).

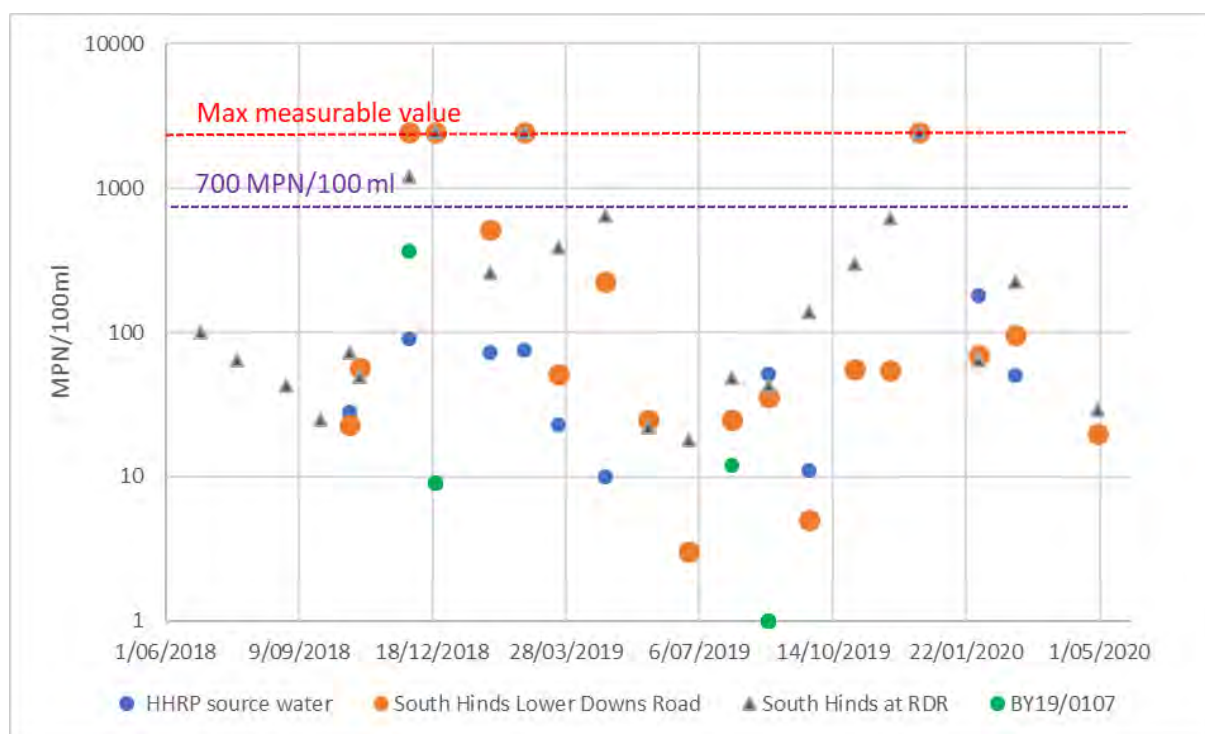
Figure 3-13: HHRP *E. coli* monitoring

The key point of interest in Figure 3-13 is whether HHRP source water contributes to increased *E. coli* counts between the up-gradient (South Hinds at RDR) and down-gradient (South Hinds Lower Downs Road) river monitoring points. If this were to occur, then a source water shutoff trigger level would be determined, as exists for the MAR Test Sites (currently at 700 MPN/100 ml). With all Year 3 and 4 source water with *E. coli* counts of less than 200 MPN/100 ml, there is no evidence for this requirement. On one occasion (30/11/2018) the *E. coli* counts between South Hinds at RDR and South Hinds Lower Downs Road increased from 1,200 to at least 2,420 MPN/100ml, but *E. coli* counts in the source water were less than 100 MPN/100ml, so the additional *E. coli* was more likely to have originated from a another source between the monitoring points. The three BY19/0107 (6 m deep, see Fig. 3-4 for location) monitoring results where *E. coli* counts were greater than 1 occurred during high river flow events when the river had high *E. coli* counts, which appears to have impacted on connected groundwater. For the majority of monitoring data points the *E. coli* counts decrease between South Hinds at RDR and South Hinds Lower Downs Road, most likely due to the addition of the HHRP recharge water.

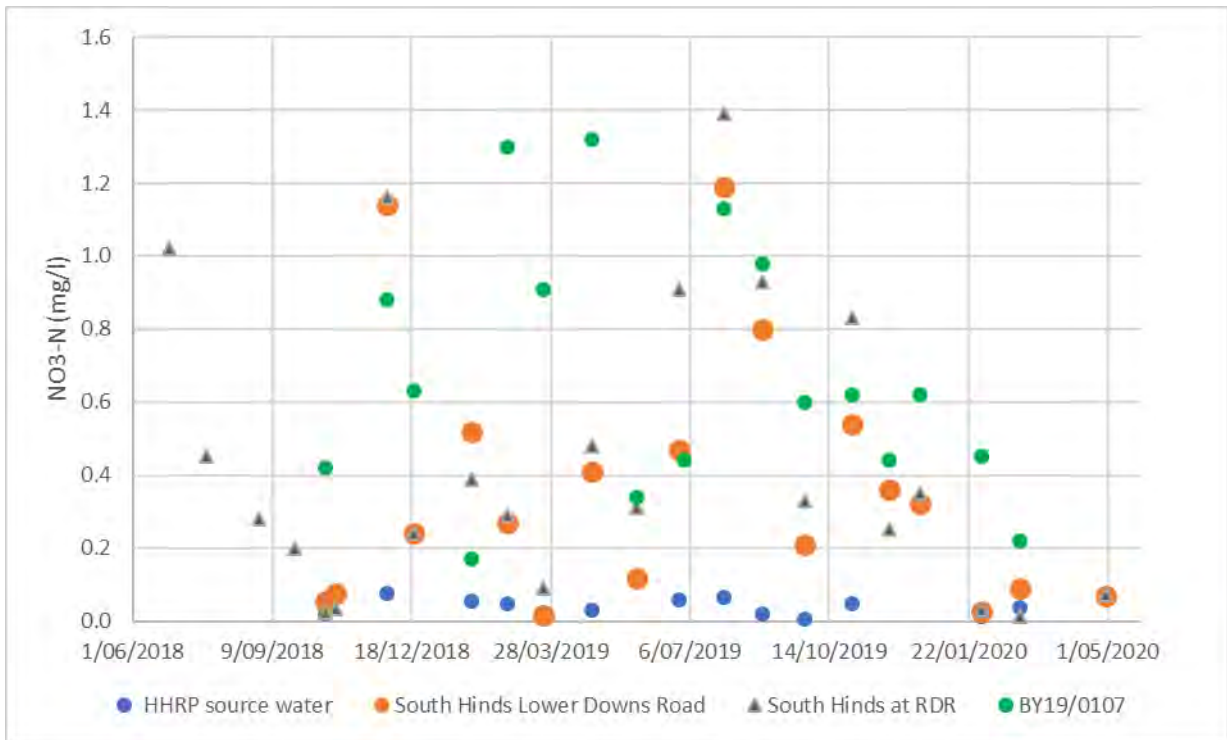
Figure 3-14: HHRP Nitrate-N monitoring

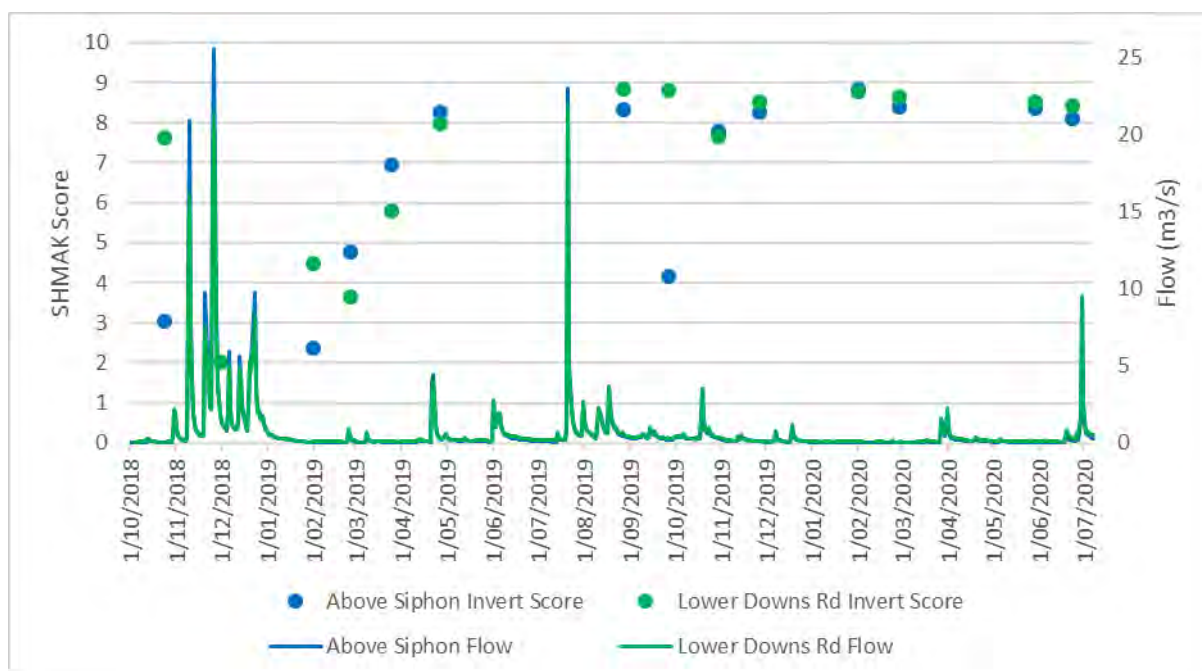
**Figure 3-17: Macroinvertebrate communities and flow regime of the Hinds River South Branch (from Dynes, 2020)**

Figure 3-17 presents the SCHMAK scores and flow to date for the above (RDR Siphon), and below (Lower Downs Bridge), sites. Both SCHMAK scores decreased after the November 2018 floods, and then took a few months to improve. Following this period, the SCHMAK at both sites increased to a score that consistently sat between 8 and 9. This indicates invertebrate communities at both sites are reflective of good water quality and habitat under relatively stable flow conditions (Biggs et al. 2002), including extended low flow periods such as early 2020.

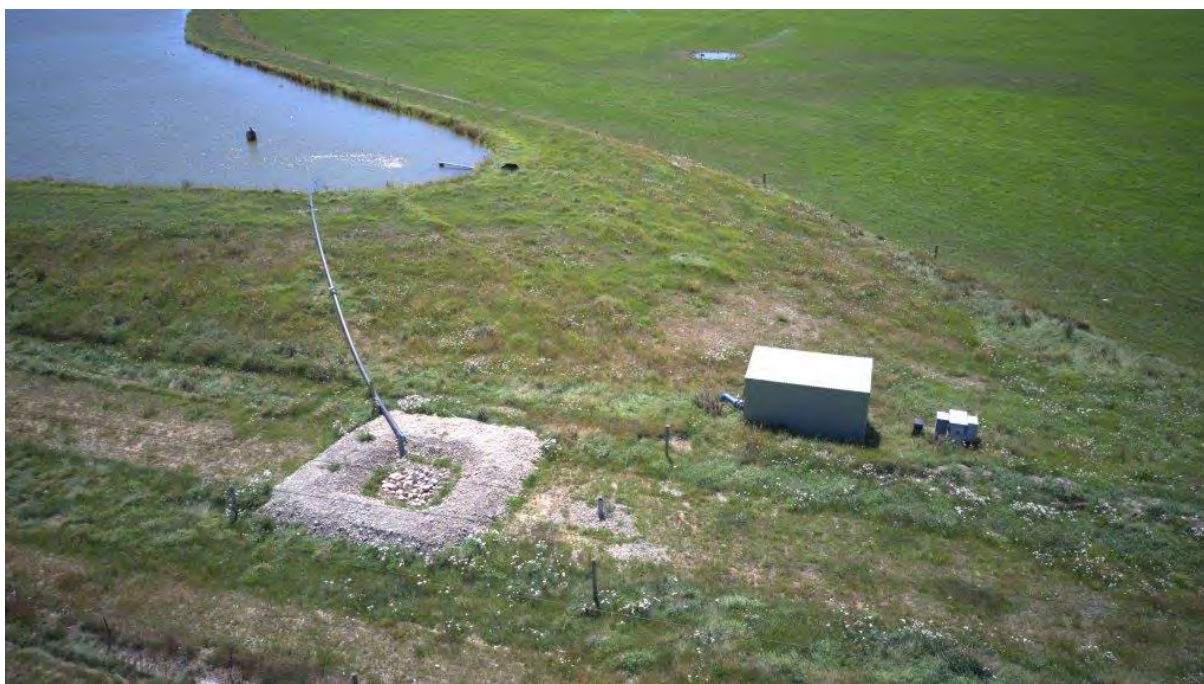
Figure 4-2: MAR 08: Lacmor test site set up

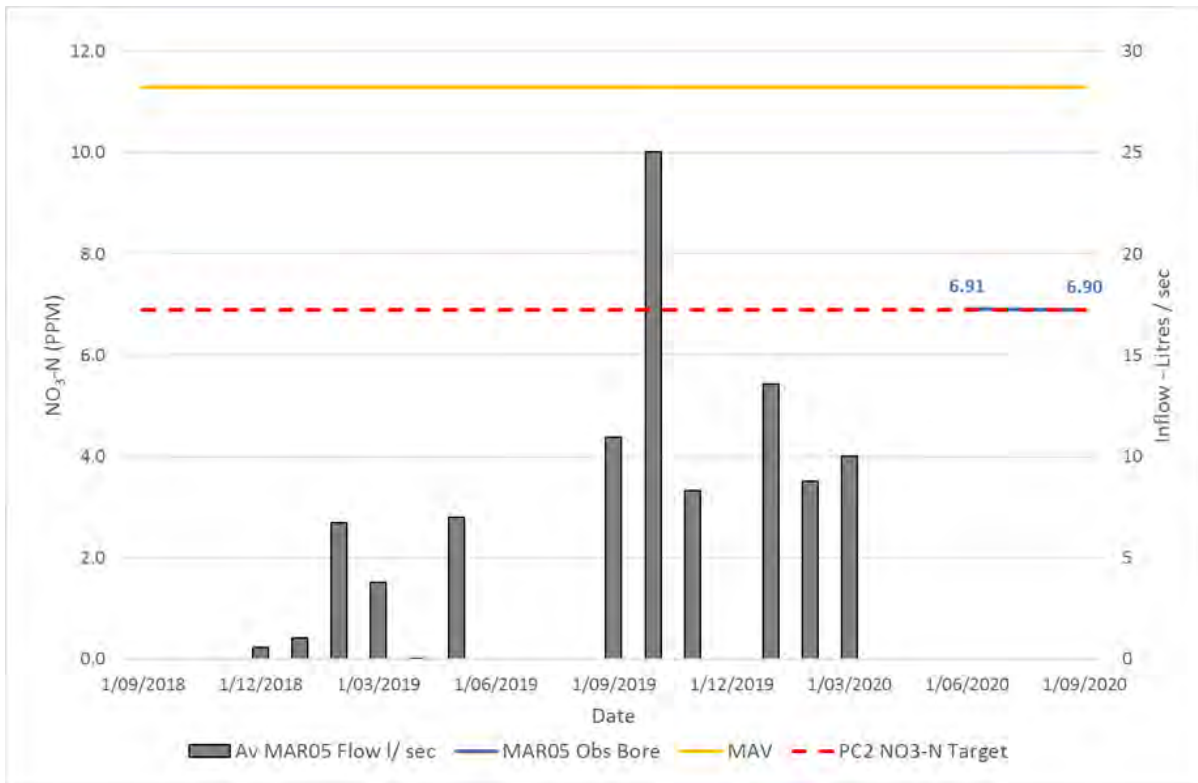
Figure 4-3: NO<sub>3</sub>-N results for a bore down gradient from MAR 05 (Source: MHV Water)

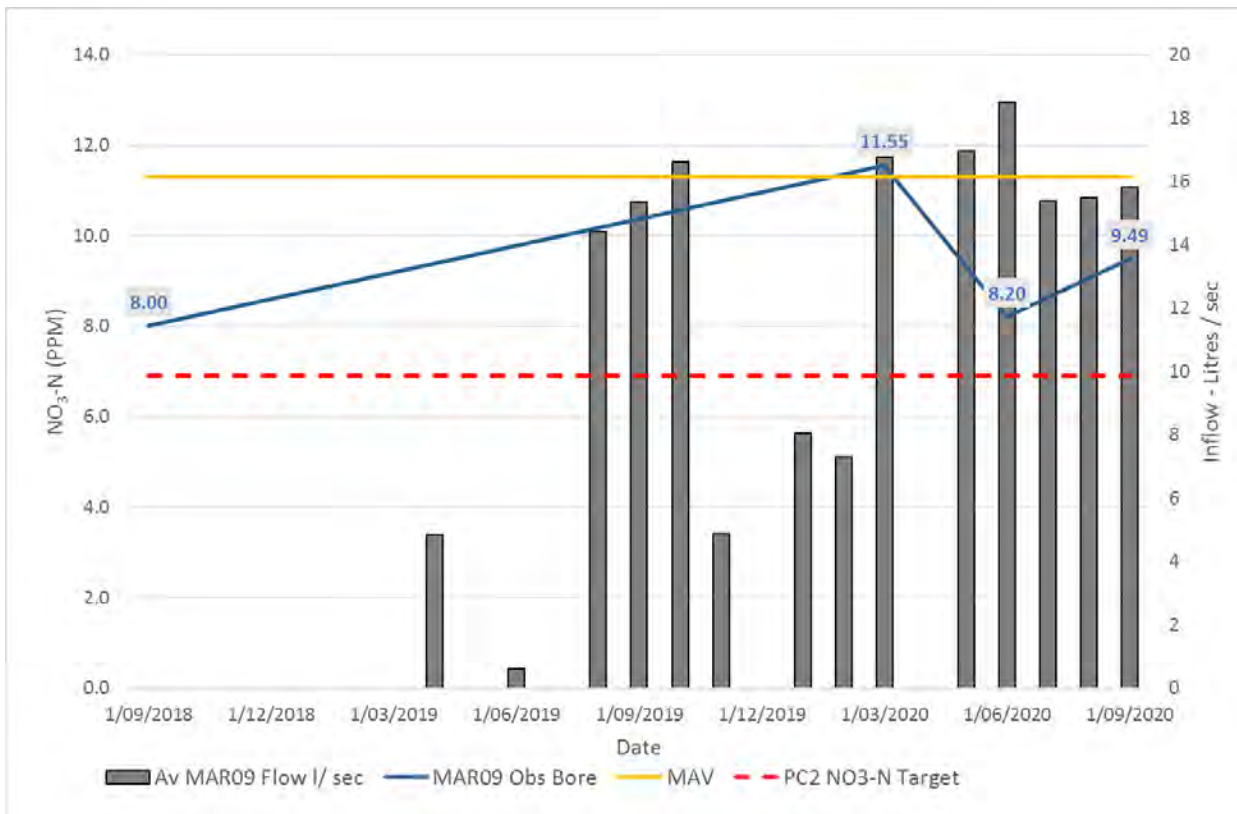
Figure 4-4: NO<sub>3</sub>-N results for a bore cross gradient from MAR 09 (Source: MHV Water)

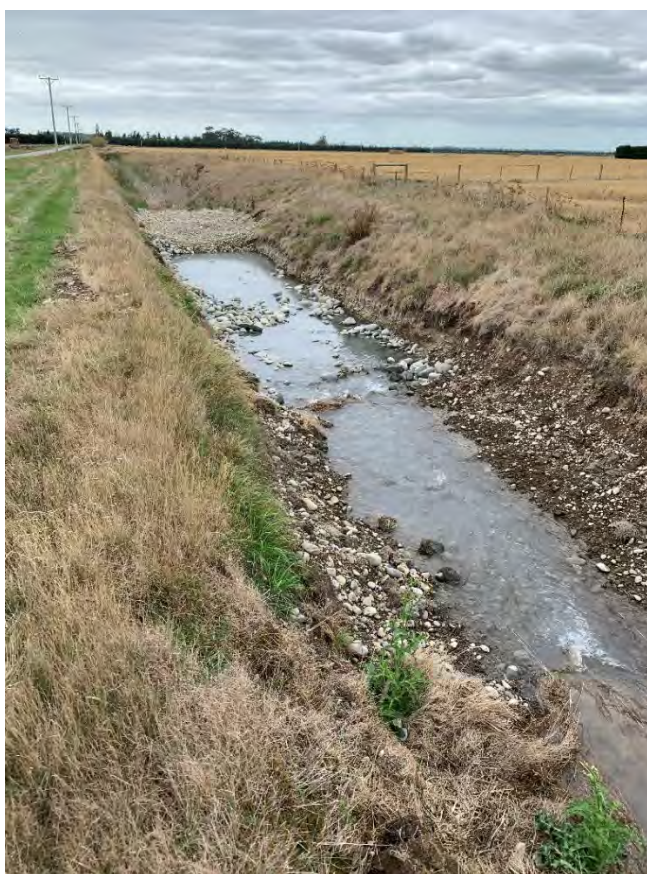
**Figure 5-1: MAR 02, Timaru Track Road**

MAR 02 (Figure 5-1) has three soakage pits, dug into the bed of 840 m of a bywash race from the Valetta irrigation distribution scheme, now unused following piping of the Valetta scheme. The race runs beside Timaru Track Road and is up-gradient from a high groundwater nitrate area that persists through to Tinwald. Construction of this site was funded by an Ashburton District Council grant, in recognition of the benefits for Tinwald residents, as well as for the groundwater ecosystem and connected lower catchment waterways. The site is connected to the end of the MHV Water Valetta piped distribution system. As MAR water supply will be limited at times of high irrigation demand, nearby stockwater races are also being considered for their supply potential. Initial testing at the site has indicated that a recharge rate at least 100 l/s is achievable. A higher recharge flow consent will be considered if this proves to be the case over an extended period. A new 33 m deep monitoring bore (BY21/0398) was drilled 1100 m down-gradient from the site and the groundwater nitrate sensor moved to this bore from BY21/0183 (see Fig. 2-10). Site operations began in Year 5, and results in terms of operation, recharge rates, nitrate concentrations and water levels, will be provided in the Year 5 report.

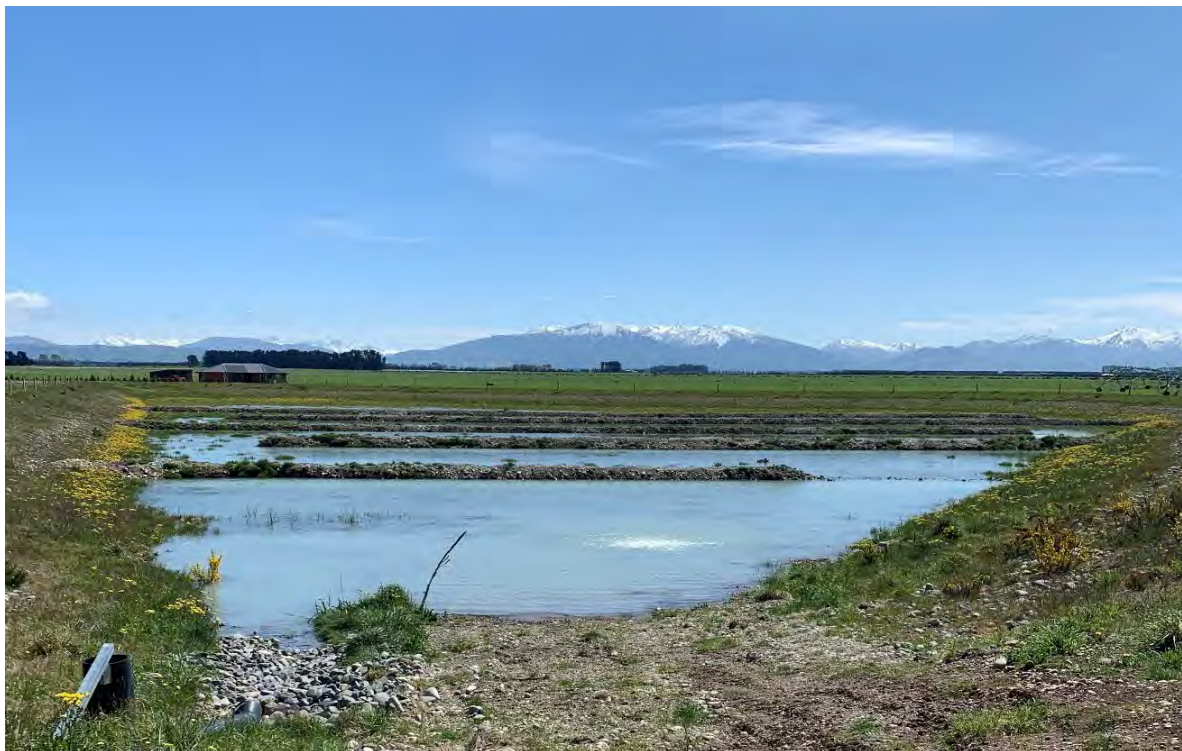
**Figure 5-2: MAR 07, Corner Timaru Track and Maronan Valetta Roads**

MAR 07 (Figure 5-2) was originally constructed as an irrigation storage pond, but the pond leaked significantly and is no longer used for this purpose. A MAR test site was constructed in the base of the pond but was only operational for 9 weeks during Year 3, as the site was connected to the farm irrigation supply and could only be operated when no irrigation was required. The new site includes a dedicated offtake and the whole of the 0.5 ha basin. Lateral bunds have been added to slow the incoming water flowrate, and thus drop out suspended sediment in the initial bays. Basin sediment is easily cleaned compared with other MAR sites, so this site will be trialled with higher turbidity water than is safe to deliver to other MAR sites, that are more susceptible to sediment clogging.

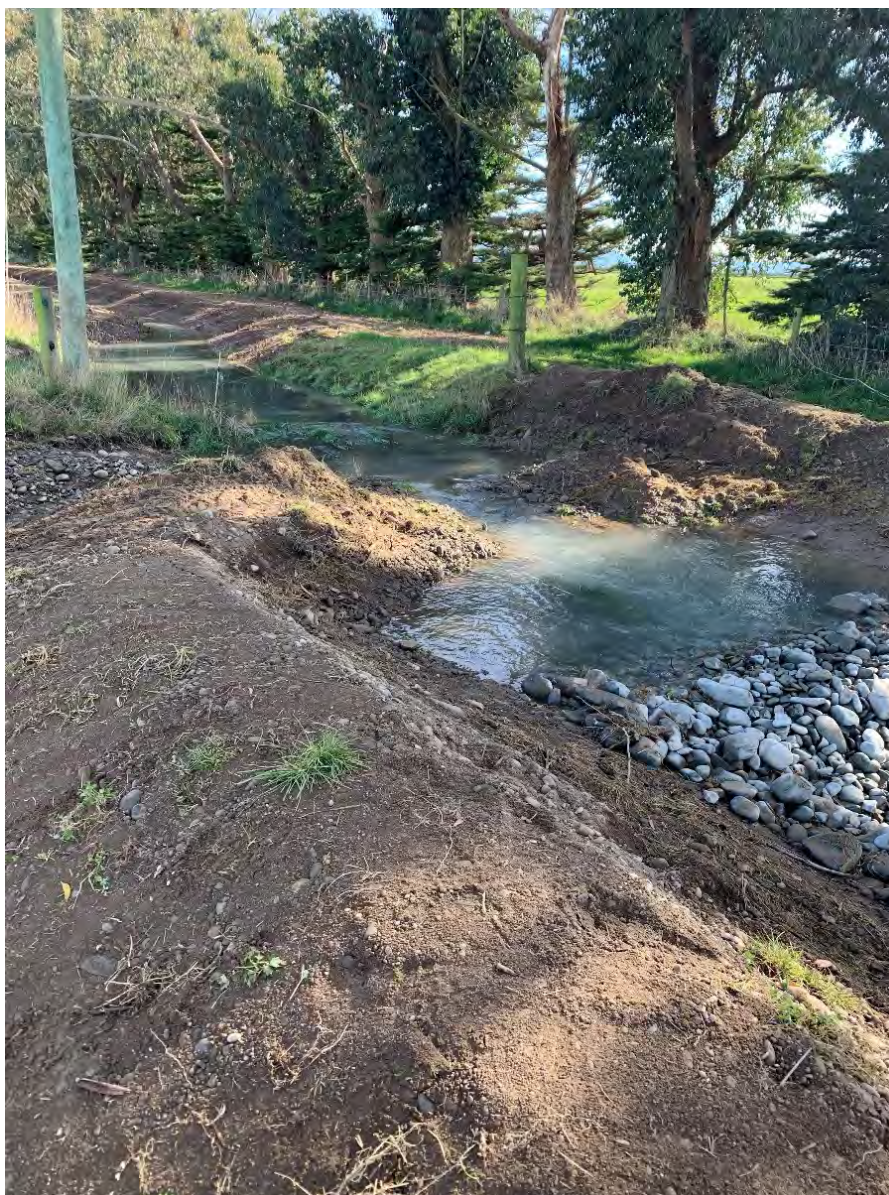
**Figure 5-4: MAR 10, off Fields Road**

MAR 10 (Figure 5-4) utilises a gate-controlled supply off an irrigation pond, followed by a supply race with multiple weirs to settle sediment, and then a cobble-filled soakage pit with perforated pipe extension. The perforated pipe extension is a recharge design used for treated wastewater recharge that doesn't take land out of production. Site operations for the new site began in Year 5. A potential bore of interest for this site (Figure 5-5) has been identified in the MHV Water groundwater monitoring program (see Section 6.3). This bore shows historical nitrate-N concentrations above the NZ Drinking Water MAV (MoH, 2018) so will be monitored and assessed for potential MAR influence over the next few years.
