Hekeao/Hinds Managed Aquifer  
Recharge Trial  
Year 4 Annual Report  
(June 2019 – May 2020)

Dr Brett Painter (Environment Canterbury)  
Justin Legg (MHV Water)

*Hekeao/Hinds Managed Aquifer Recharge Trial - Year 4 Annual Report*

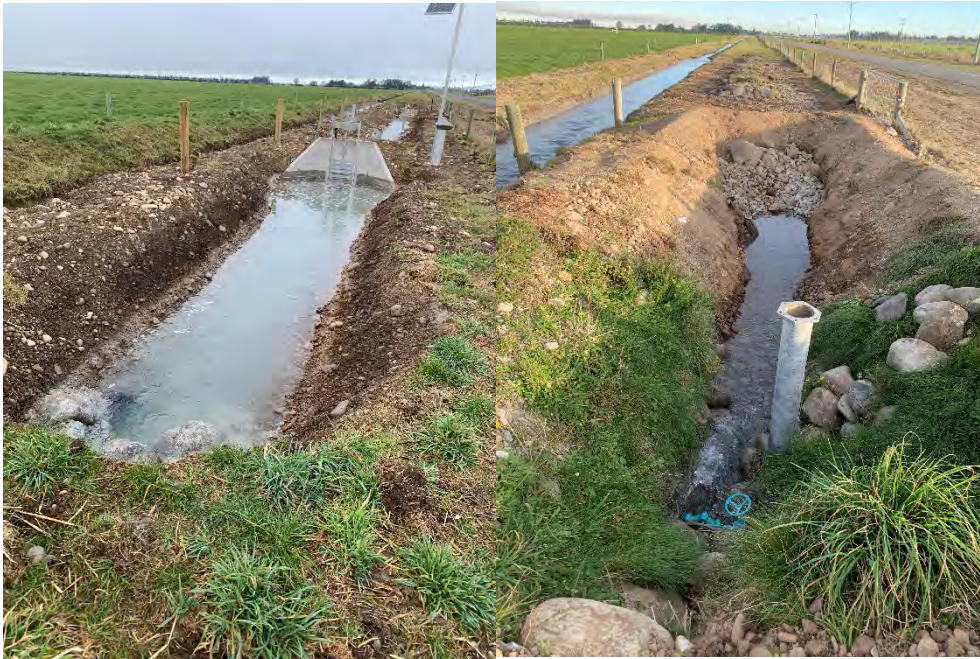
Figure 5-6: MAR 12, Maronan Ealing Road, up gradient (left) and down gradient (right)

MAR 12 replaced a test site at the same location which did not perform well, due to sediment and *E. coli* management challenges. The new site is fed by the same water race as the test site (left of Figure 5-6), with an open channel sediment forebay trench, connected to a soak hole and down-gradient buried perforated pipe. Initial testing early in Year 5 suggested recharge rates of 30-50 l/s were possible (up from a maximum of 13 l/s at the original site). Operation of the new site began in Year 5. A potential bore of interest for this site (Figure 5-7) has been identified in the MHV Water groundwater monitoring program (see Section 6.3). This bore shows a nitrate-N concentration decrease following the start of new site operations, but a longer monitoring time period is required before MAR influence can be assessed. A groundwater nitrate sensor has also been installed in nearby bore BY20/0148 (in which, water quality exceeds the NZ Drinking Water MAV for nitrate-N), but this has not showed improved water quality (which is consistent with expectations that it is sited cross-gradient from MAR 12).

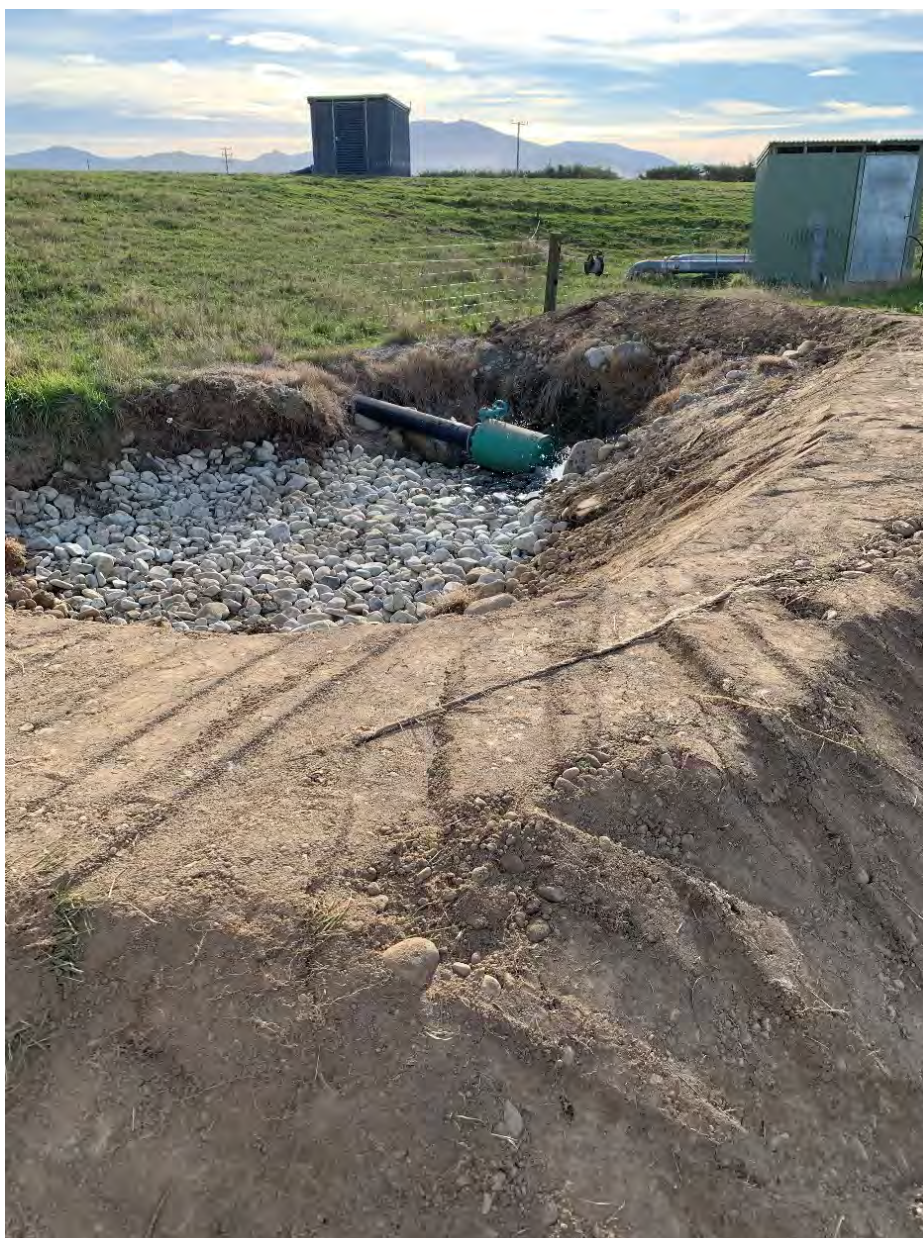
**Figure 5-8: MAR 13, Hinds Arundel Road**

MAR 13 (Figure 5-8) was originally a standard test site connected to an irrigation pond. After recharge rates declined (most likely due to sediment clogging), an identical site was built immediately adjacent to, and connected to, the test site. This has increased recharge rates from 15-20 l/s up to 20-40 l/s. A potential bore of interest for this site (Figure 5-9) has been identified in the MHV Water groundwater monitoring program (see Section 6.3). This bore shows nitrate-N concentrations close to the NZ Drinking Water MAV (MoH, 2018) and will be monitored and assessed for potential MAR influence over the next few years.

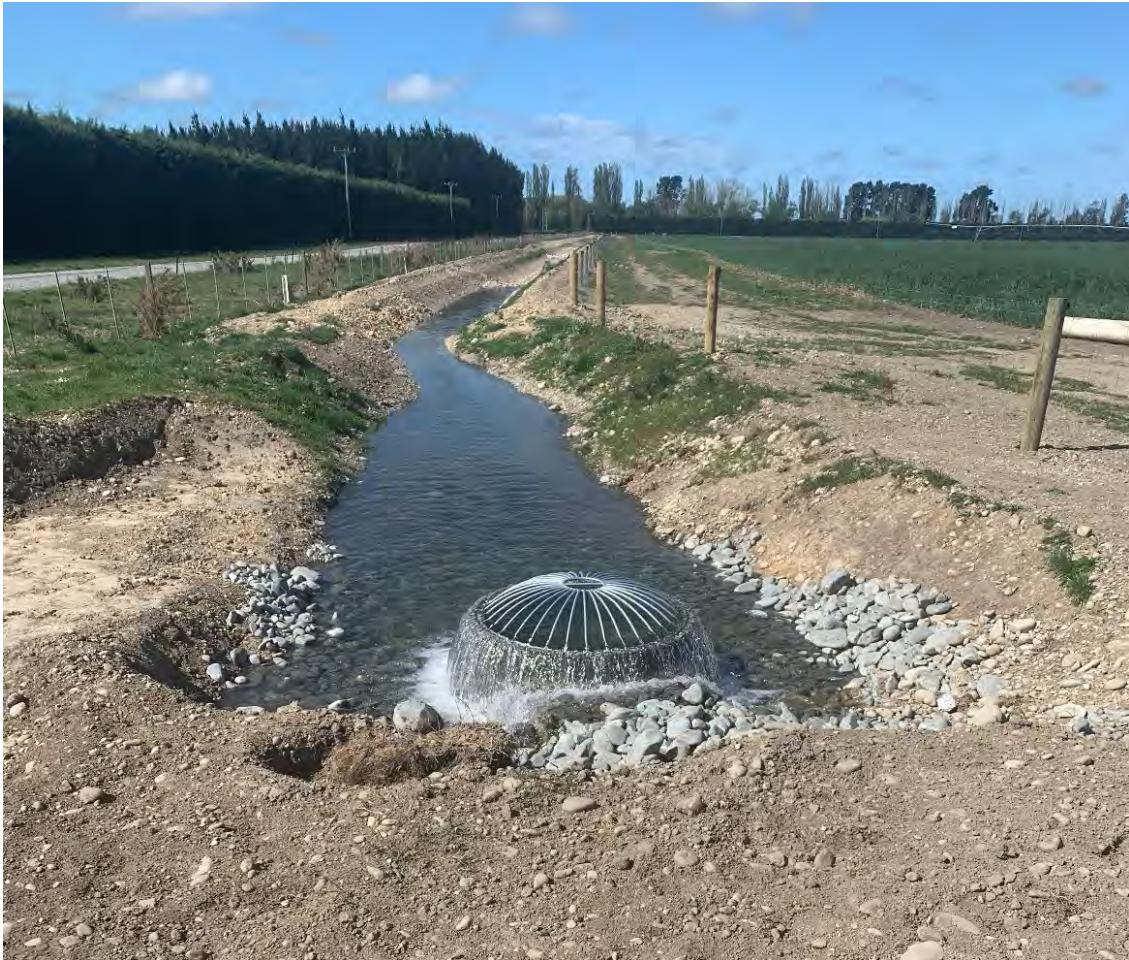
**Figure 5-10: MAR Site 17b, Lennies Road**

MAR 17b (Figure 5-10) is supplied from an irrigation pond, ~700 m from the Hekeao Hinds River and heads towards the river (at ~45° to the hydraulic gradient), along a recharge race with multiple weirs and soak holes. An alternative consented site (17a), situated slightly up-gradient, is not expected to be constructed following benefit / cost comparisons between 17a and 17b. The site became operational early in Year 5 with recharge rates of 45-75 l/s. The current lateral race has the capacity for additional expansion if the site maintains this level of performance. Two potential bores of interest for both MAR 17b and MAR 18 (Figure 5-11) have been identified in the MHV Water groundwater monitoring program (see Section 6.3). Bore 2 showed a temporary decrease in nitrate-N concentrations immediately following the onset of MAR site operations, nearly matching the concentrations at Bore 1 (which only has recent monitoring results). However, concentrations then returned to level more similar to pre-MAR concentrations. Both bores will be monitored and assessed for potential MAR influence over the next few years. The banks of MAR 17b have also been prioritised for native planting, in consultation with mana whenua and the landowner.

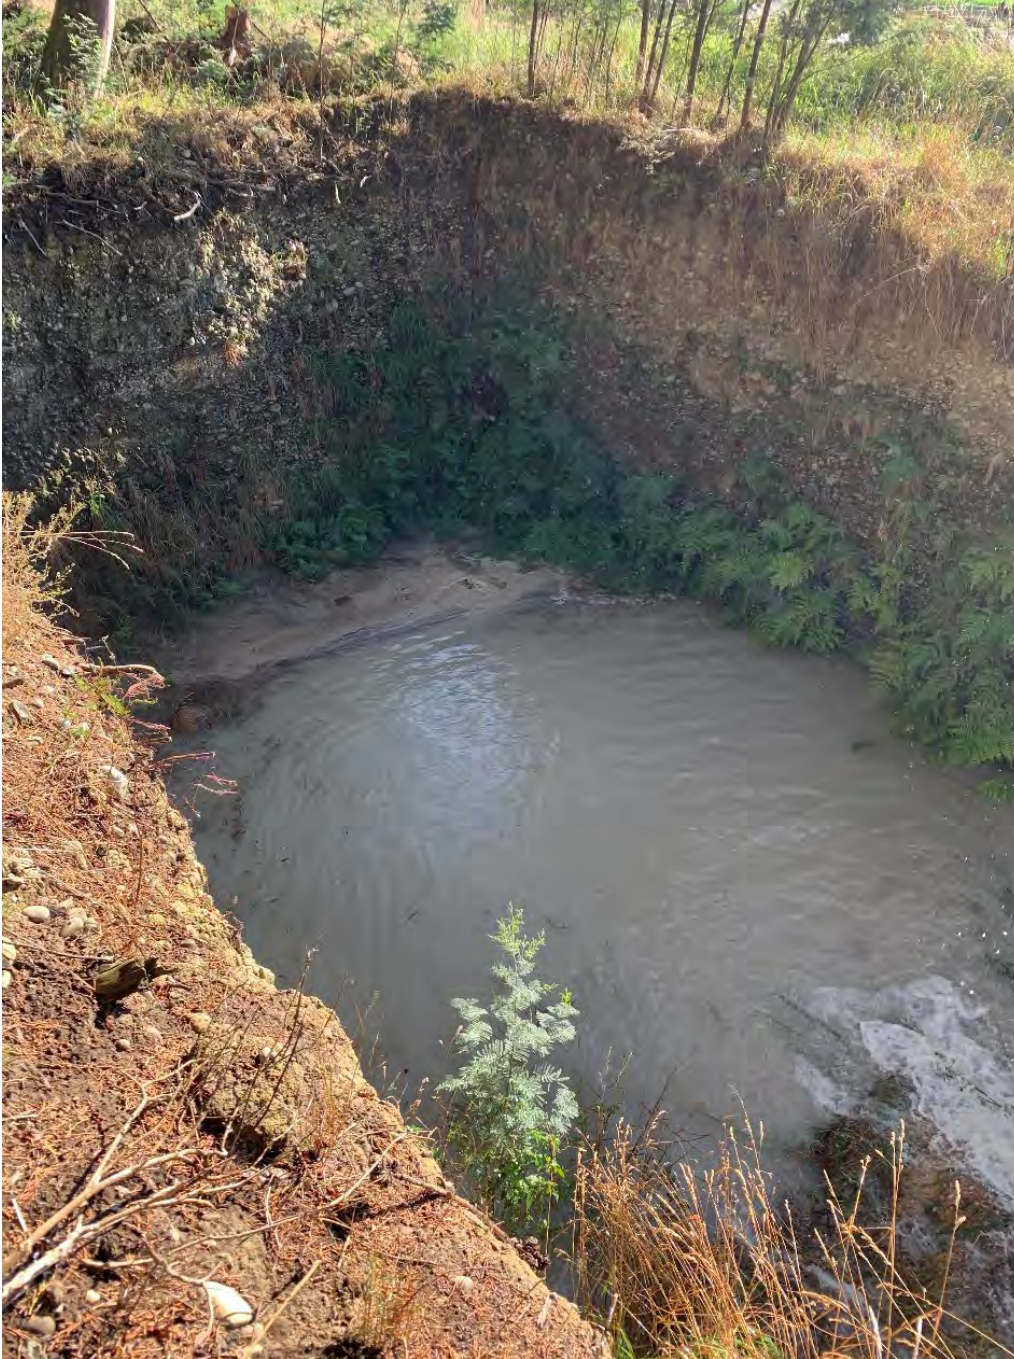
**Figure 5-12: MAR Site 18, McDougalls Road (infiltration testing prior to backfilling)**

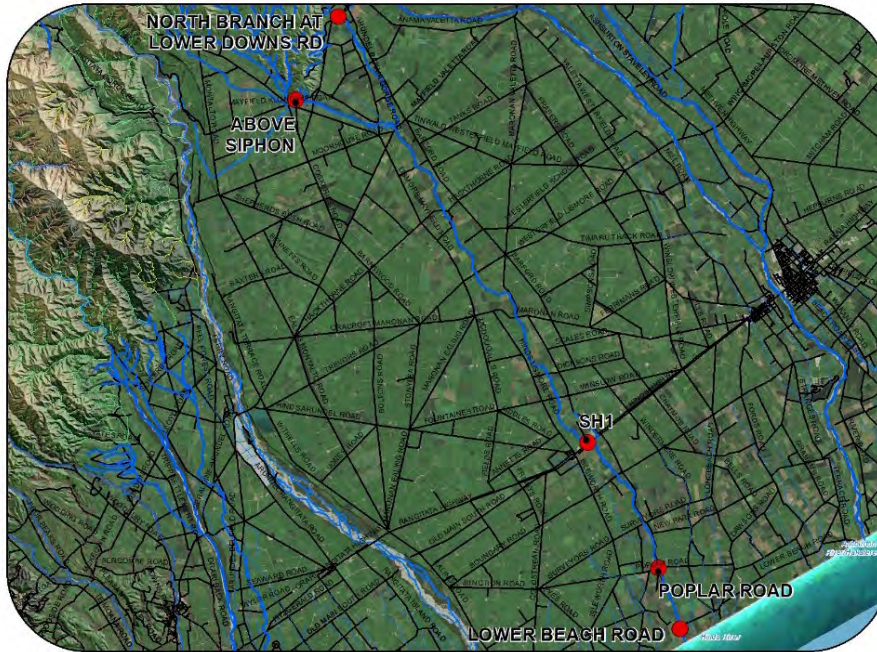
Figure 6-8: Hekeao Hinds River monitoring sites (Source: HDWP, 2020)

Figure 6-8 presents the locations of current Hekeao Hinds River monitoring sites. Figure 6-9 presents the mean daily flows for the Hekeao Hinds River at Poplar Rd. The drought from mid-2014 to mid-2017 provided an extended period of low flows (primarily due to low groundwater) and no significant freshes. Figures 6-10 and 6-11 present the water quality (nitrate and nitrite as nitrogen) and ecology (Quantitative Macroinvertebrate Community Index - QMCI) results, to date, for the lower river sites. Baseflows in the mid/lower river are heavily influenced by spring-fed stream inflows. The Lower Beach Rd site is generally in excess of the LWRP limits for nitrate for the Hekeao Hinds River. A comparison of Figures 6-9 and 6-10 shows that low NNN concentrations can occur after a large fresh (due to dilution with low nutrient rainwater) and after periods of low flows (due to reduced land surface recharge). Aquatic ecosystem health monitoring at SH1, Poplar Rd and Lower Beach Rd sites indicates the QMCI for the upper two sites (SH1 and Poplar Rd) generally do not meet the minimum QMCI objective of 6. QMCI seems to improve further downstream at the Lower Beach Rd site where stream flow is more consistent. The past two seasons have shown an improved QMCI, likely influenced by a return to higher baseflows and more regular freshes following the mid-2014 to mid-2017 drought. As MAR capacity is increased near the middle reaches of the Hekeao Hinds River, it is possible that the water quality and ecology of the River, from SH1 downstream, (particularly during low flow periods) will improve. Monitoring and analysis will continue to assess the impacts of ongoing MAR.
